**SOUTH PORTLAND CENTRAL FIRE STATION
& POLICE STATION FACILITIES STUDY**

**684 Broadway & 30 Anthoine St,
South Portland, ME 04106**

CITY OF SOUTH PORTLAND, MAINE

AUGUST 25, 2021

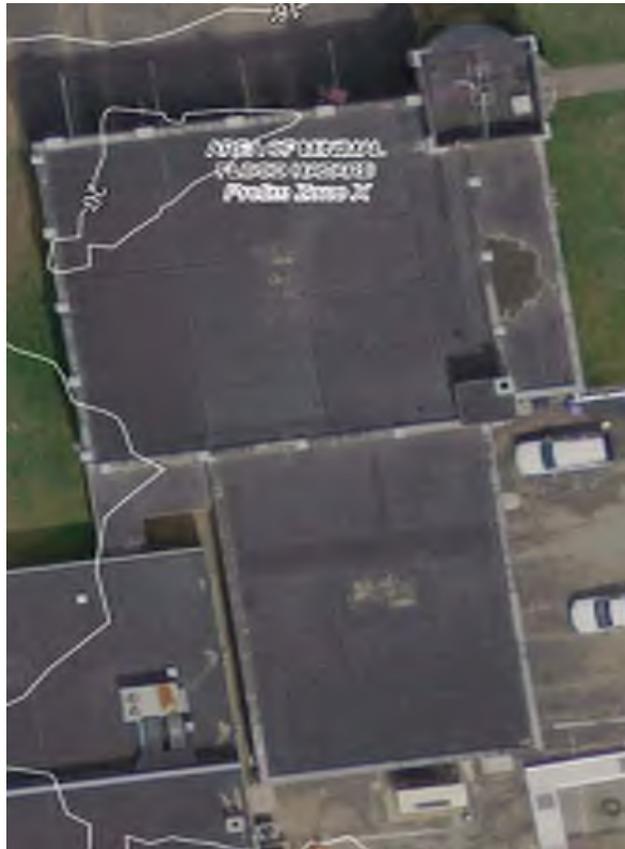
1. The roofing review for the Central Fire Station is based on observations made during a site visit. No specifics are known about the age, or makeup, of the existing roofing materials. Based on conversations it appears that the existing roofing is at least 20 years old. There are a number of repair areas visible for the existing roofing. Options 1, 2, 3 & 4 involve re-use of all/portions of the existing Central Fire Station. For this work, we have considered that any areas retained in these options will be 100% re-roofed. New roof is assumed to consist of R-30 insulation with 0.060 mil EPDM roofing. New insulation to be mechanically fastened and the membrane adhered.

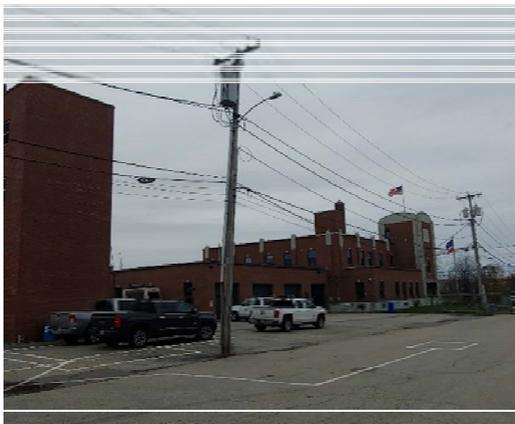
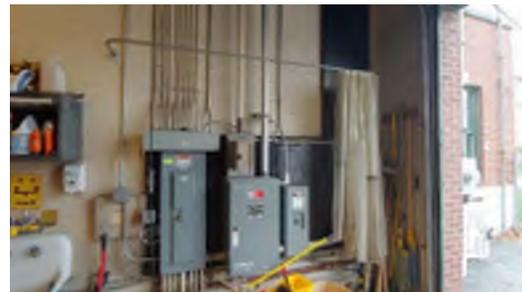
1. The Central Fire Station has two 208/120-volt three phase overhead services, one serves the 10-horsepower SCBA compressor and the other serves the remainder of the building. The services originate at a pole-mounted utility-owned 112.5-kVA transformer that also serves the 1997 building of the Police Station. The service equipment is located in a vehicle bay that is used for washing vehicles; a shower curtain has been installed to protect the equipment from splashing water, but a vehicle washing area is typically classified as a wet location under the National Electrical Code (NEC), and the equipment is suitable only for dry locations.

Each service terminates at an enclosed circuit breaker. The circuit breaker for the SCBA service is rated 100 amps and is an obsolete Cutler Hammer breaker that appears to be approximately 40 years old and has exceeded its anticipated useful life. The building service circuit breaker is a 200-amp Square D breaker that we estimate was installed in the late 1990's.

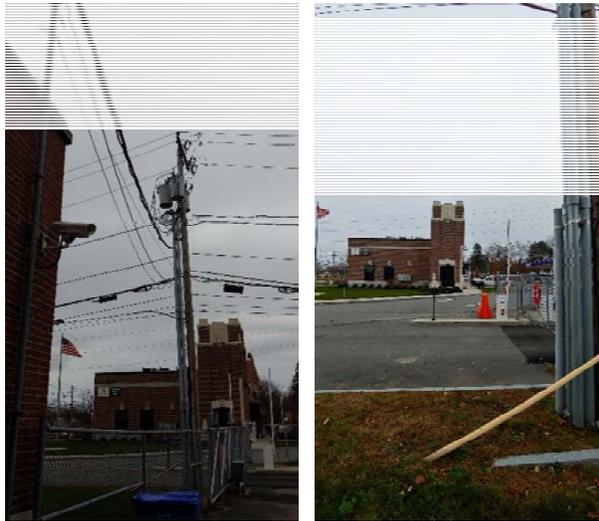
It should be noted that the utility pole located adjacent to the fire station building, which is the last pole before the utility service drop connects at the building, serves an underground service to the former armory building across armory street. It may be necessary to modify the service to that building to facilitate construction of a new police/fire station building, depending on which renovation/construction option is selected.

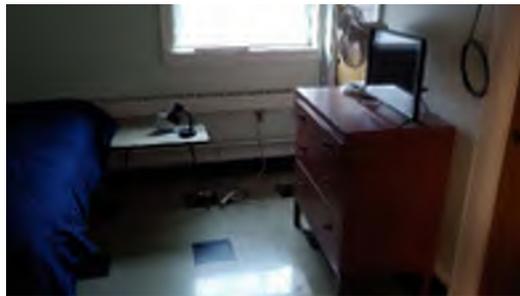
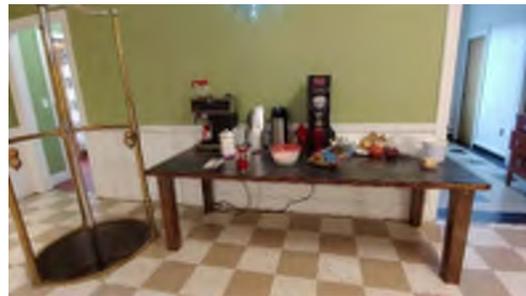
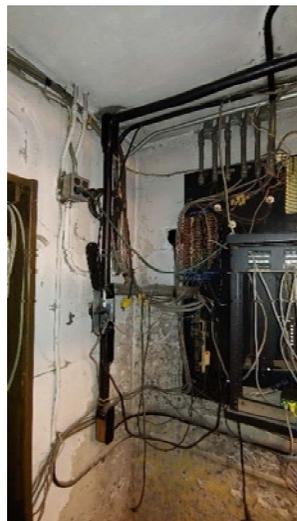
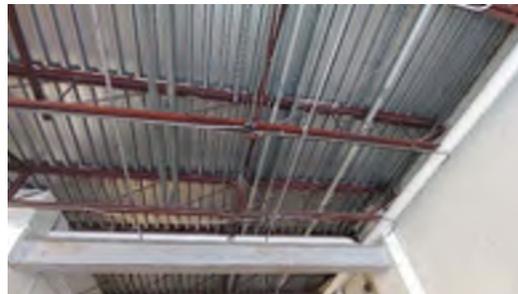
Based on what can be seen from a simple walk-through of the facility, general line-voltage wiring appears to be a mixture of building wire in conduit and type MC metal-clad cable. The wiring varies in age and condition as the system has been modified over the years to accommodate changing needs, but some of the conduits likely house wiring that is quite old and exceeded its anticipated useful life. Open junction boxes were observed in some areas, exposing live wires within.

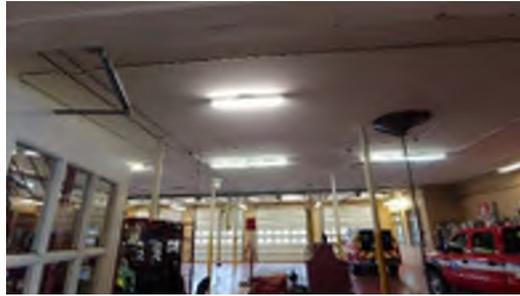
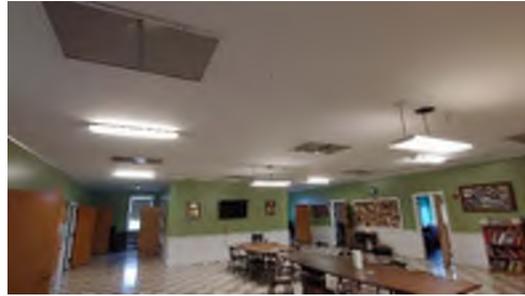
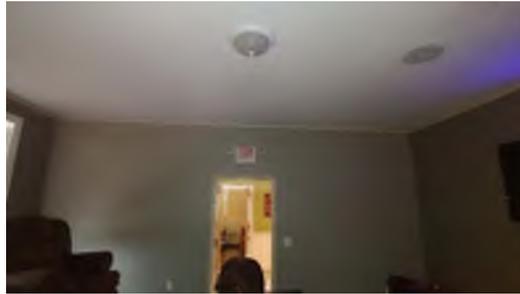
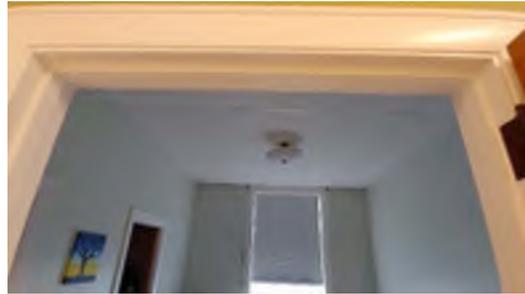
5. Interior lighting in most areas is provided by various styles of fluorescent luminaires. It appears that many fixtures utilize linear T8 fluorescent lamps and, presumably, electronic ballasts, although obsolete T12 lamps remain in the fixtures in the vehicle bays. Newer decorative ceiling mounted fixtures that appear to utilize Edison base bulbs are installed in the bunk rooms and TV room. The interior lighting is controlled by manual switches.

There are some battery powered emergency lights for means of egress and internally illuminated exit signs to mark means of egress, but the coverage is not up to current standards.

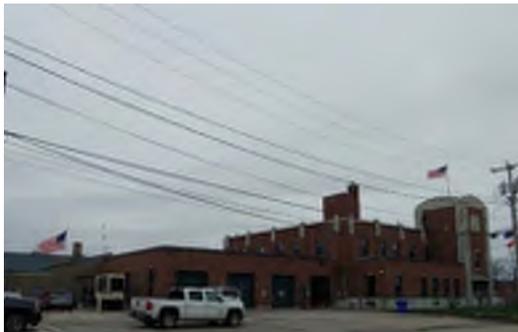
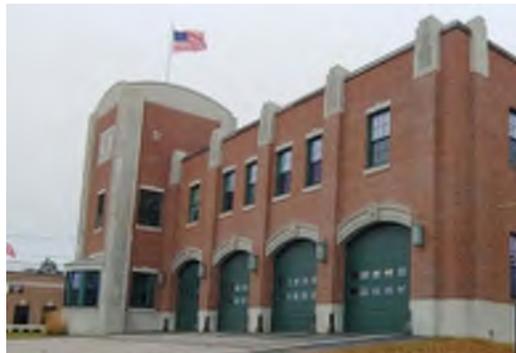
6. Exterior lighting is provided by a mixture of old decorative fixture and newer high-intensity discharge (HID) fixtures. The exterior lighting is controlled by photocells. The fixtures appear to be in fair to good condition but are obsolete.

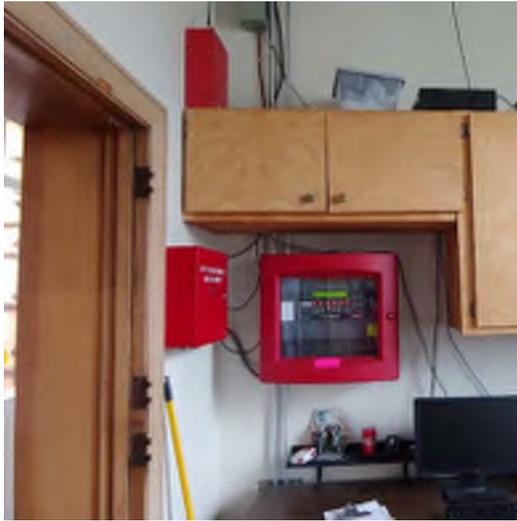
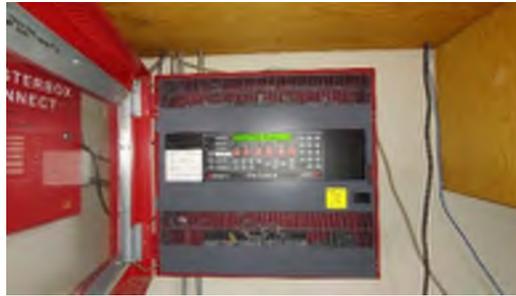
7. The facility is equipped with a Simplex addressable fire alarm system controlled by a 4010 ES series control panel that is connected for remote monitoring via an AES radio master box. Bunk rooms are equipped with detectors that appear to have smoke and carbon monoxide sensors. Heat detectors are installed in the apparatus bays. While the control panel and installed detectors appear fairly new, occupant notification appliances are not located as would be required by current standards for a new facility; there are no notification appliances in the bunk rooms or apparatus bays.

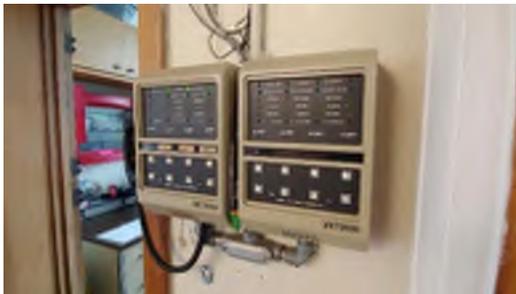
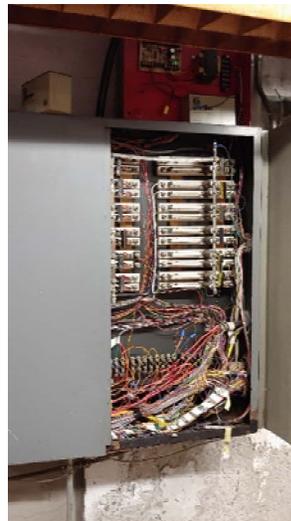
8. A Zetron fire station alert system is in place to alert the station of alarm calls. There is a cabinet in the basement that contains numerous connections for a municipal call box loop; the City's insurance carrier has reportedly raised concerns about potential hazards associated with this wiring. At the time of our site visit, an electrician was reportedly scheduled to ascertain what voltages, if any, are present in the wiring.

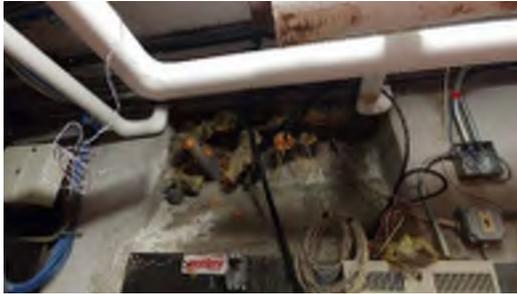
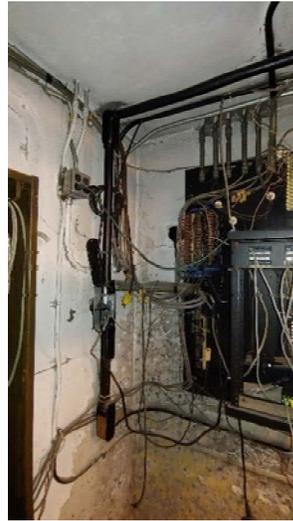
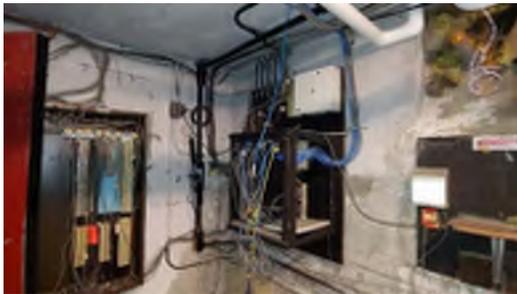
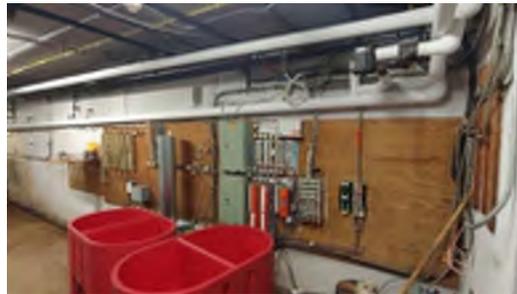
The current location for the data rack and utility demarcation is undesirable because the basement floor is below the flood plain.

Much old telecommunications wiring that is likely no longer in use and abandoned was observed in the basement and, to a lesser extent, in other areas of the building. Identifying and removing unused wiring would benefit the facility as it is mandated by current code and would simplify design and renovation efforts.

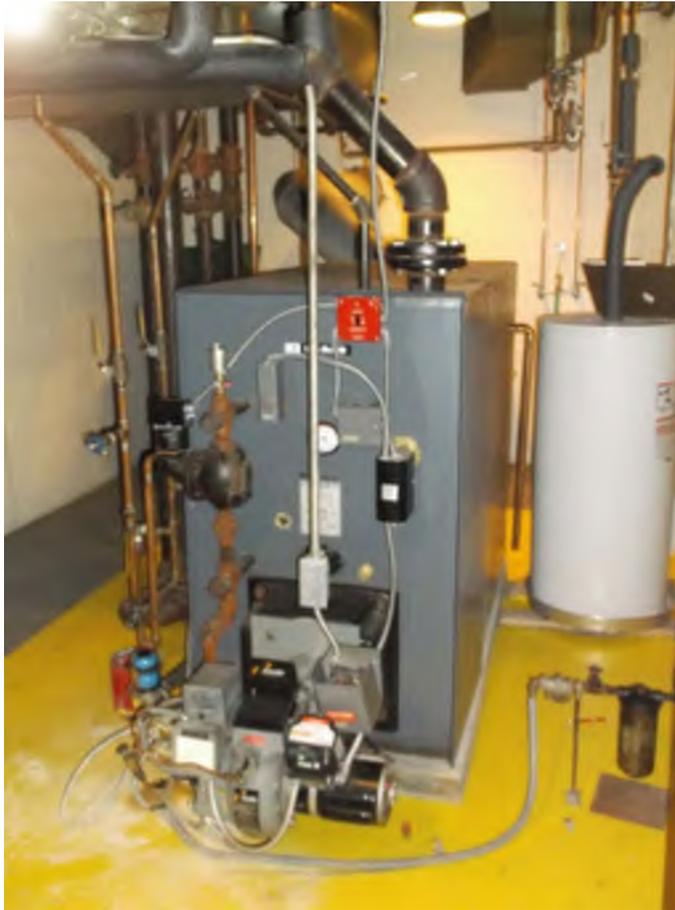
1. The building heating hot water is generated by a single cast iron sectional Weil McLain hot water boiler, model 978, gross output 1,007 MBH, firing #2 fuel with a Carlin burner. Heating fuel oil is stored in an underground storage tank with a monitored leak detection system. This boiler does not appear to be of original 1960's vintage, but no documentation is apparent which would offer to establish the year of installation.

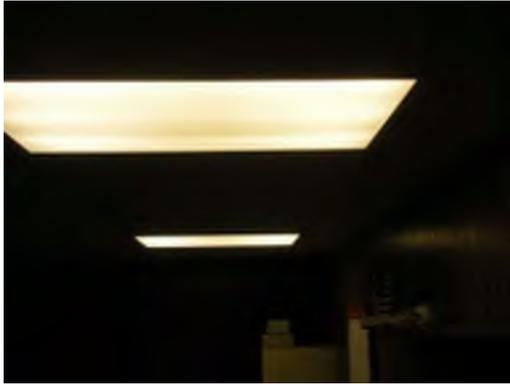
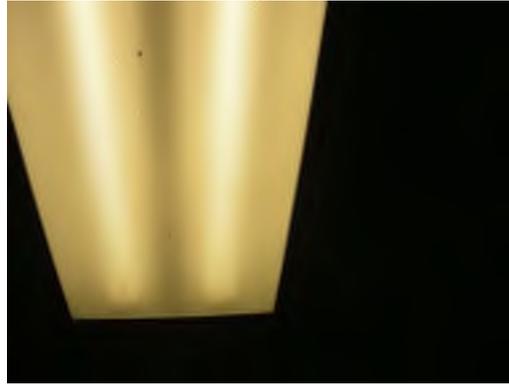
today the recessed lighting located in the firing range is in poor condition, non-energy-efficient, and the lighting control itself, while functional, is not listed or approved as required current NEC standards.

Discolored Lenses Create Dim Lighting (TYP)

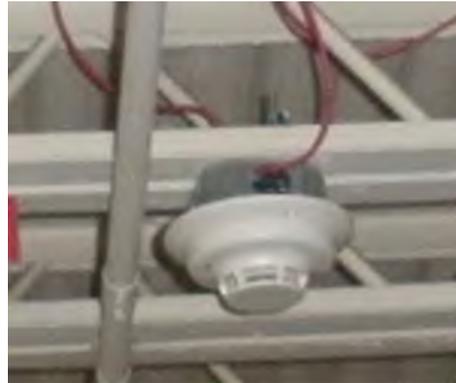
Improperly Terminated and Secured Fire Alarm Cable (TYP)

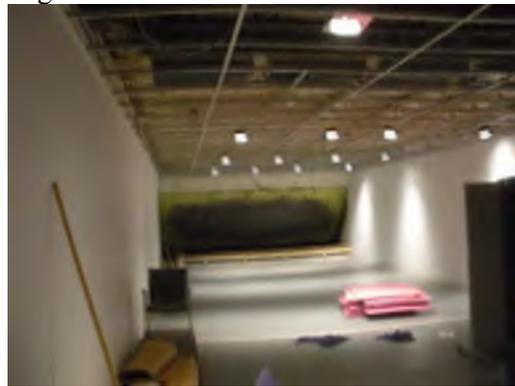
Light Fixtures Improperly Supported

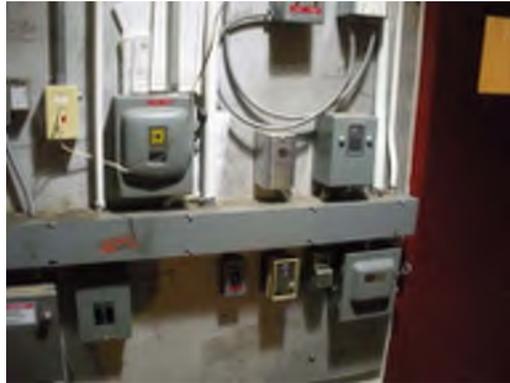
Questionable Functionality and Inadequate Labeling

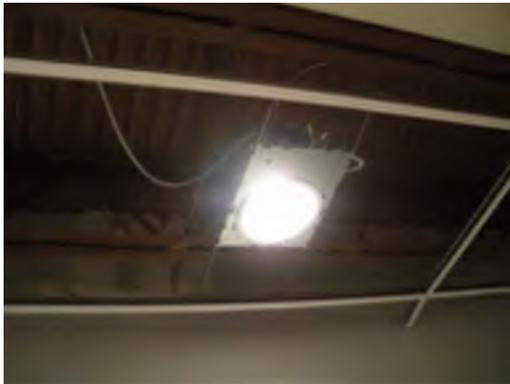
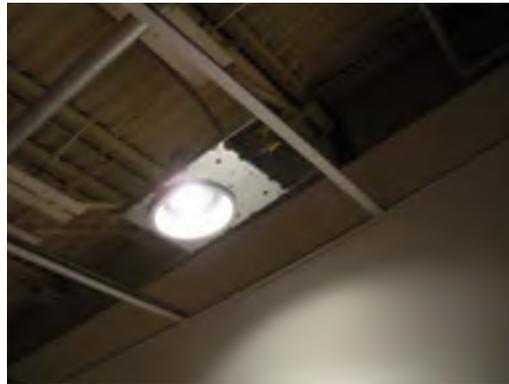
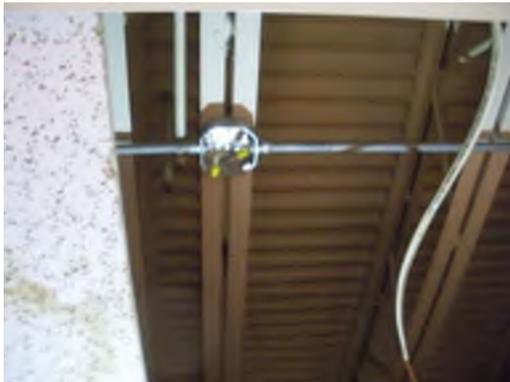
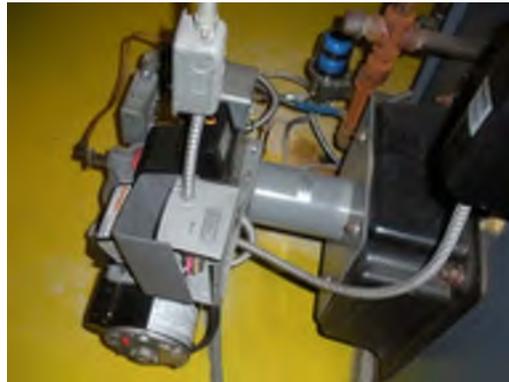
Open Splices
(NEC and OSHA Code Violations)

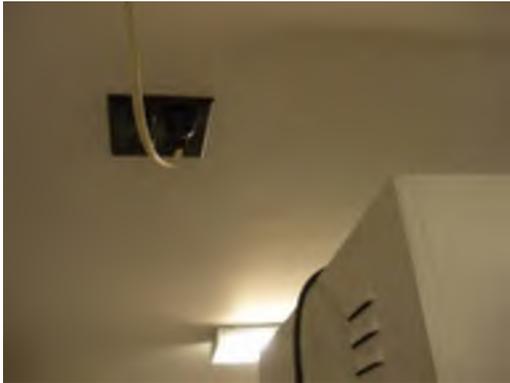
Improper Use of Cord Cap and Romex

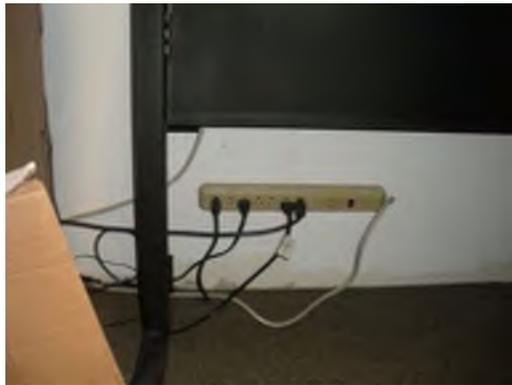
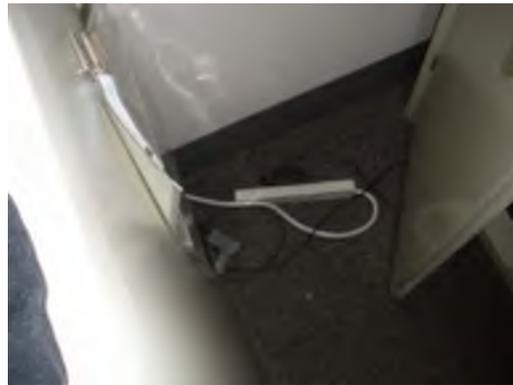
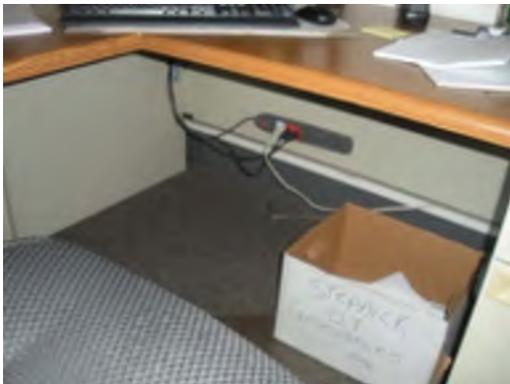
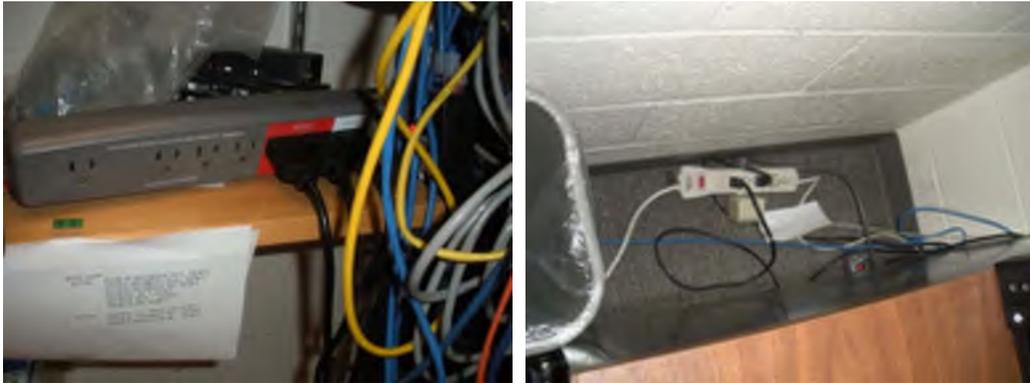
Extensive Use of Extension Cords and Power Strips (TYP)

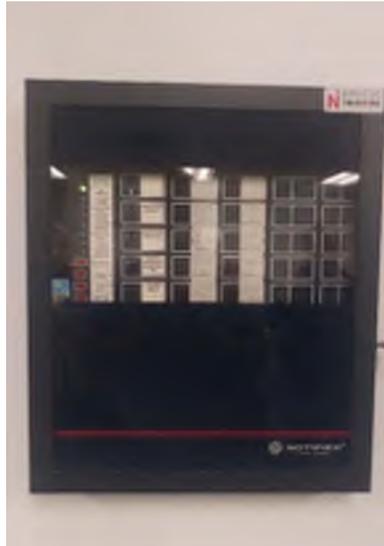
Main Fire Alarm Control Panel

1997 Building is equipped with a conventional zoned Notifier fire alarm System that also serves the 1967 building. The control panel is a System 500 series and appears to be original to the building. Alarms are initiated by manual pull stations at exits and smoke and heat detectors located in selected areas. There is also a separate Chemetron control panel that controls a dry-chemical fire suppression system in the basement server room. It was observed that some of the fire alarm cabling installed in the police building was not properly secured and terminated.

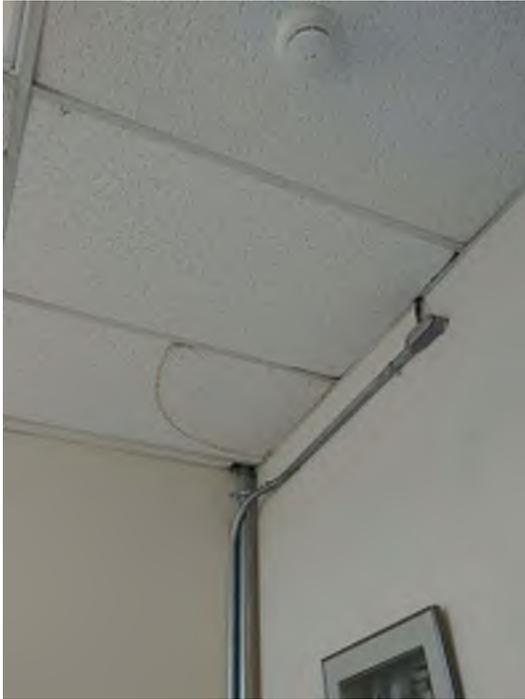
Water stained ceiling tile (Senior Man's Office)

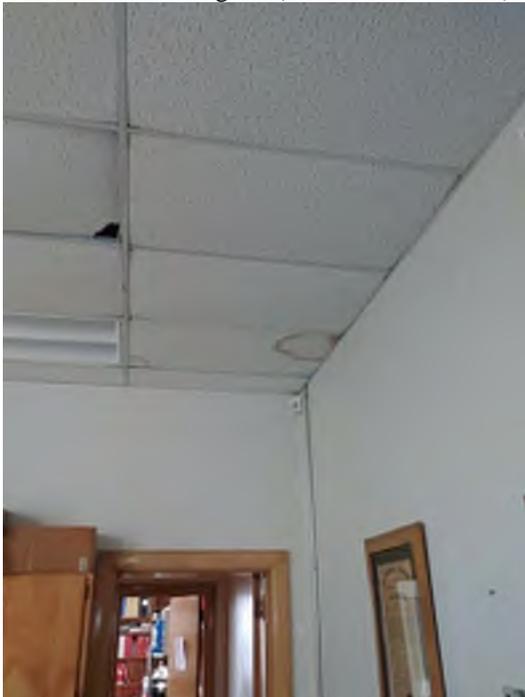
Water stained ceiling tile (Senior Man's Office)

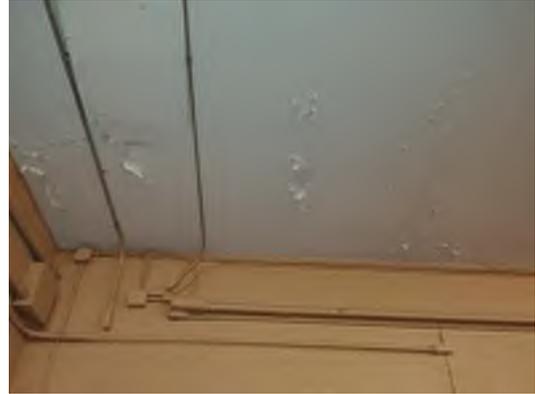
Peeling Paint in Bays

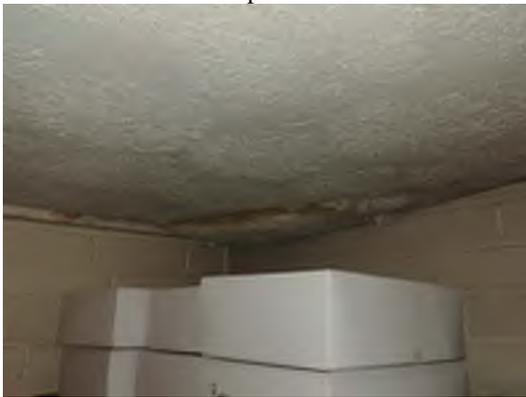
Water damaged ceiling in EMS Storage

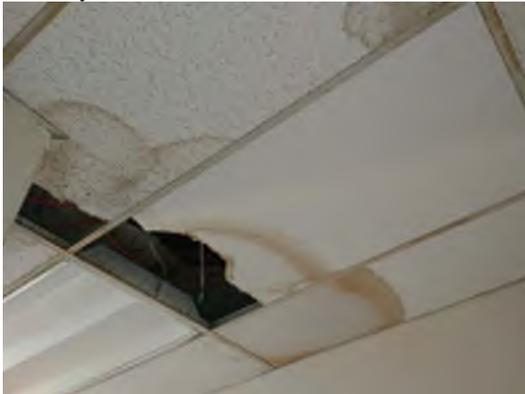
Water damage in 2nd floor Hallway

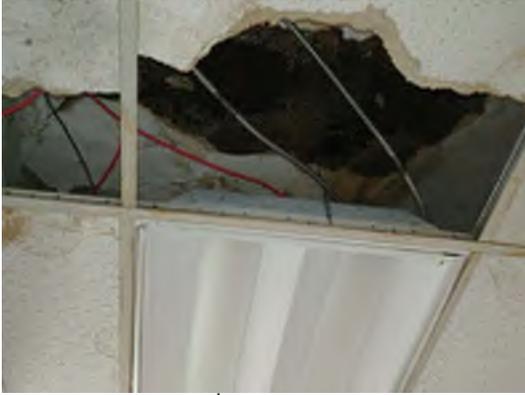
Water damage in 2nd floor Hallway, plaster above ceiling tiles

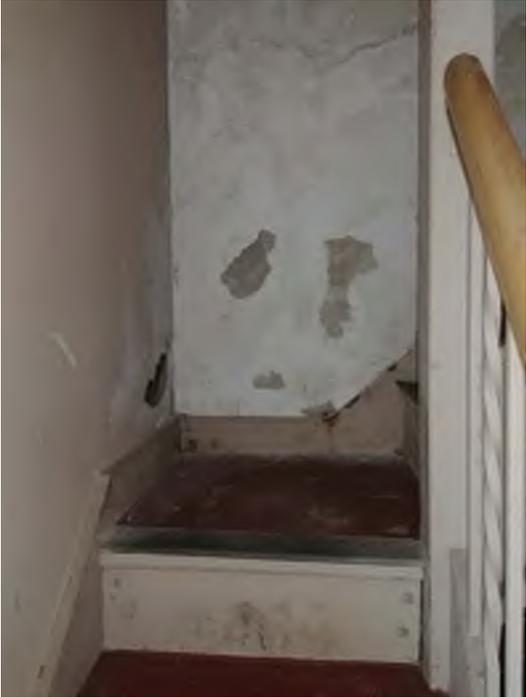
Water damage in Stairwell to Attic

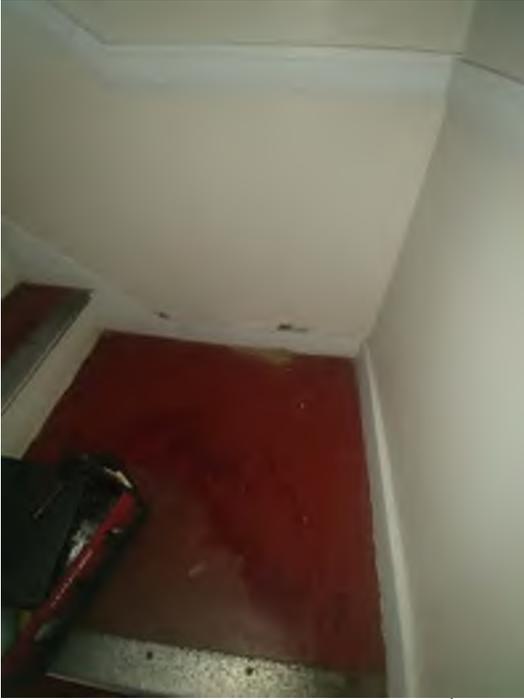
Water damage in Stairwell Landing (to 2nd floor), location of sample T1

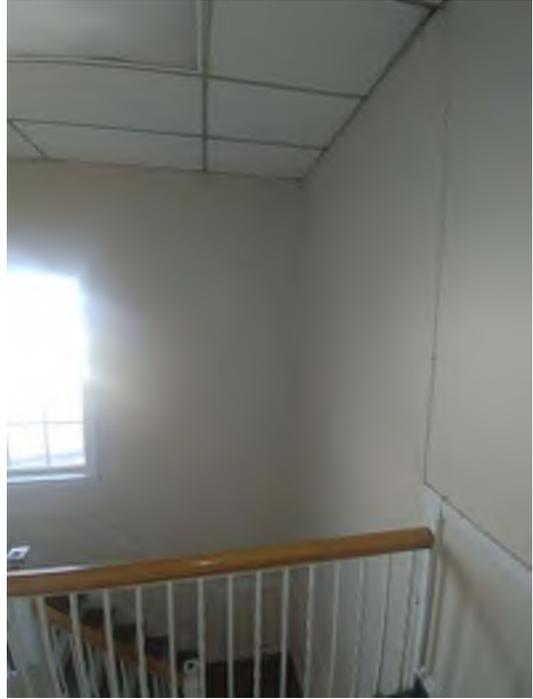
Water damage in Stairwell

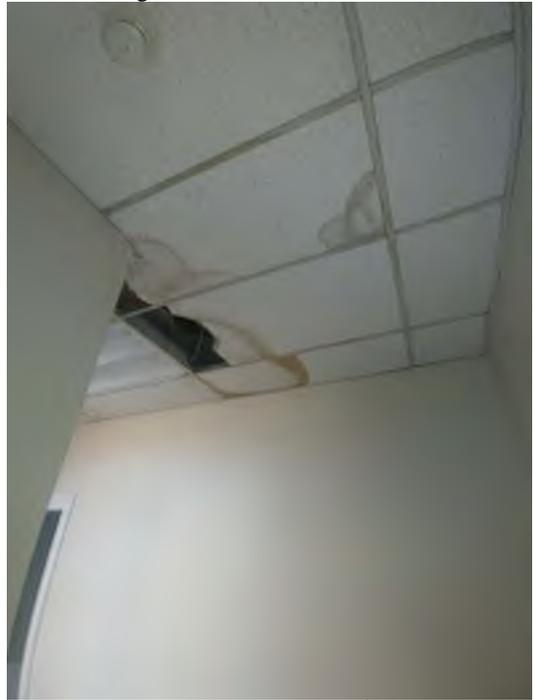
Water damaged ceiling tiles in 2nd floor Hallway

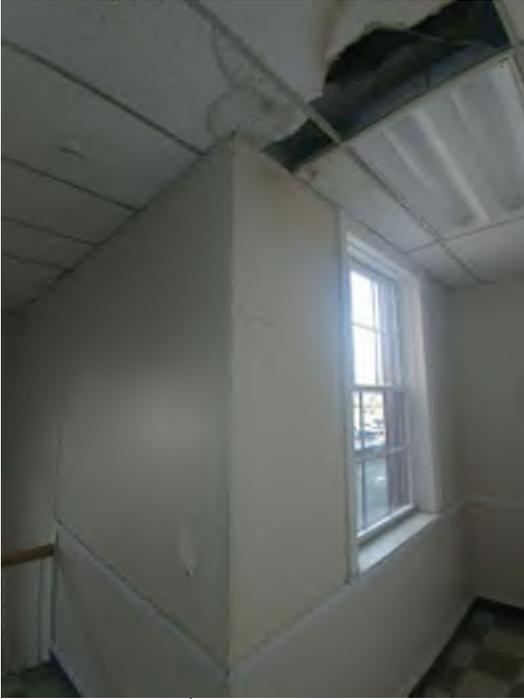
Water damage 2nd floor Hallway

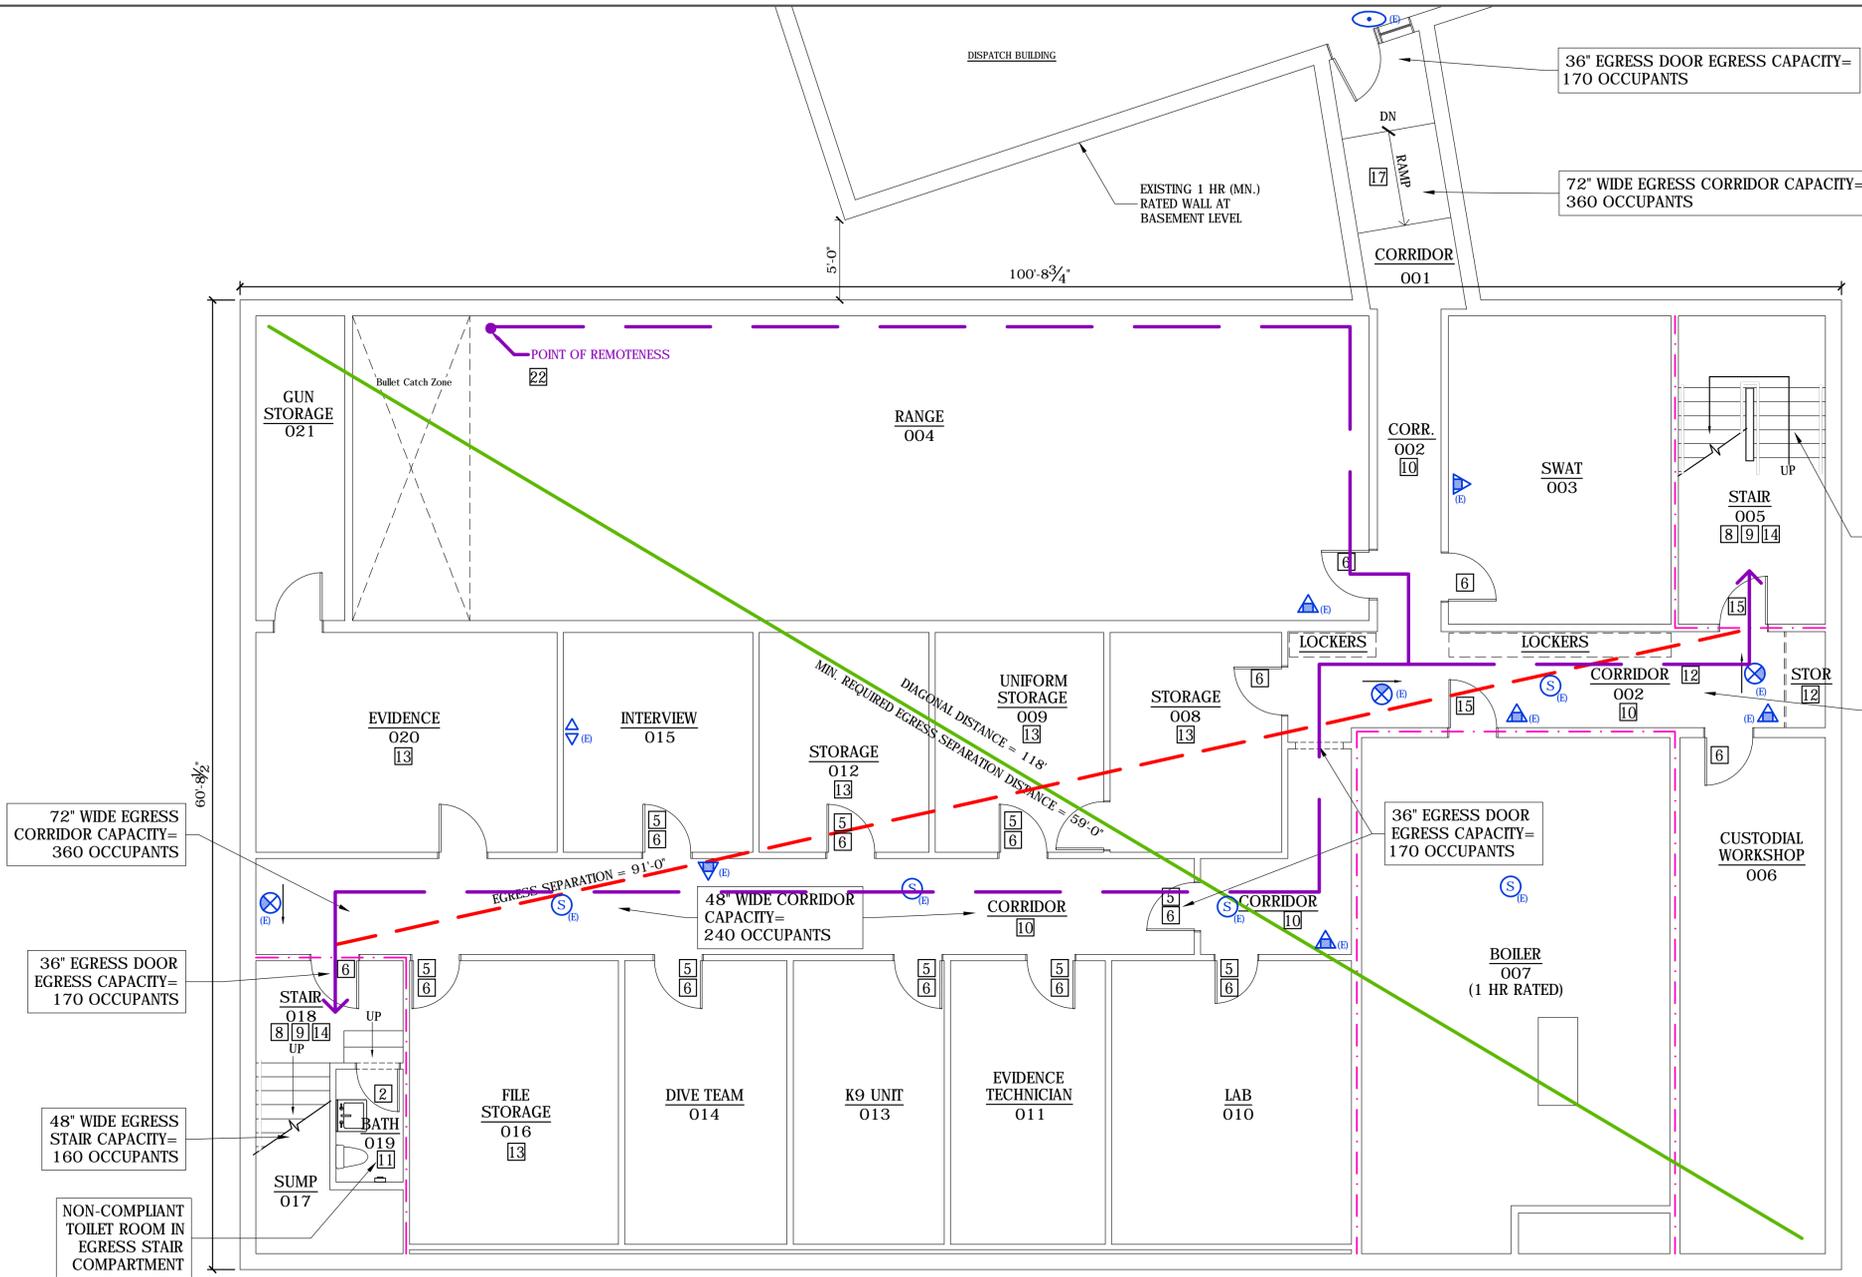
PUBLIC SAFETY BUILDING BASEMENT CODE COMPLIANCE PLAN
 SCALE: 3/16" = 1'-0" 6,110 SF

BUILDING KEYED NOTES LEGEND	
1 REQUIRED EXIT DOES NOT COMPLY WITH ADA (NEEDS RAMP +/- 13'-0").	14 STAIR RISER / TREAD DO NOT COMPLY.*
2 TOILET ROOM DOES NOT COMPLY WITH ADA (DIMENSIONAL CRITERIA).	15 FIRE RATED DOOR DOES NOT HAVE POSITIVE LATCHING HARDWARE.
3 SINK DOES NOT COMPLY WITH ADA (NOT WHEELCHAIR ACCESSIBLE).	16 SHOWER NOT ADA COMPLIANT.
4 DOOR DOES NOT COMPLY WITH ADA (NOT WHEELCHAIR ACCESSIBLE).	17 RAMP DOES NOT HAVE ADA HANDRAIL BOTH SIDES.
5 DOOR HARDWARE NOT ADA COMPLIANT (KNOB).	18 NO SPRINKLER IN ROOM.
6 DOOR ASSEMBLY NOT 1 HR FIRE RATED AT EGRESS CORRIDOR (NON-SPRINKLED).	19 TOILET ACCESSORY HEIGHT DOES NOT COMPLY w/ ADA.
7 DOOR DOES NOT HAVE ADA WHEELCHAIR MINIMUM CLEARANCE APPROACH @ HARDWARE.	20 RANGE DOES NOT HAVE NFPA EXHAUST HOOD.
8 STAIR RAILING DOES NOT HAVE CODE COMPLIANT EXTENSIONS.*	21 ELEVATOR LOBBY NOT SEPARATED FROM EGRESS STAIR FIRE RATED ENCLOSURE.
9 STAIR RAILING HEIGHT / OPENINGS DO NOT COMPLY.*	22 MAXIMUM ALLOWED EGRESS TRAVEL DISTANCE DOES NOT COMPLY WITH IBC / NFPA 101

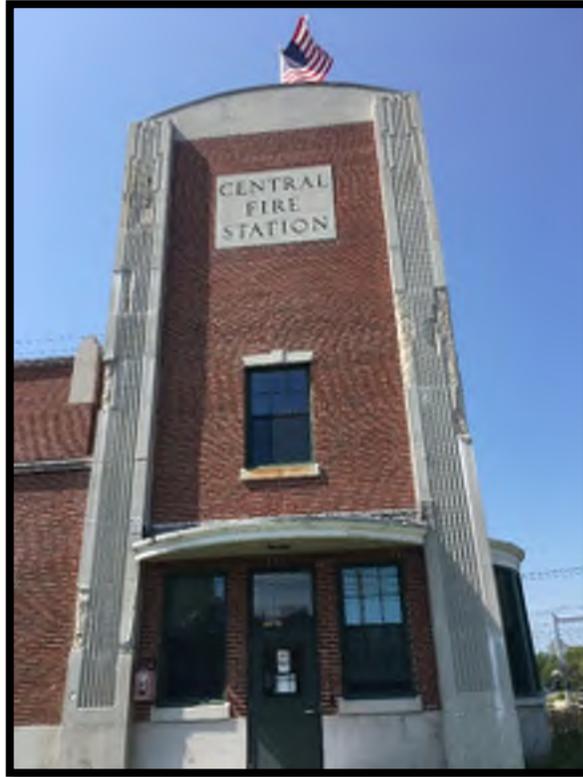
Deteriorating Façade
