# Red Brook Watershed Based Management Plan

June 2011

Cumberland County Soil & Water Conservation District  
for the  
Town of Scarborough

Prepared by Cumberland County SWCD  
in cooperation with the  
Town of Scarborough and the  
Maine Department of Environmental Protection

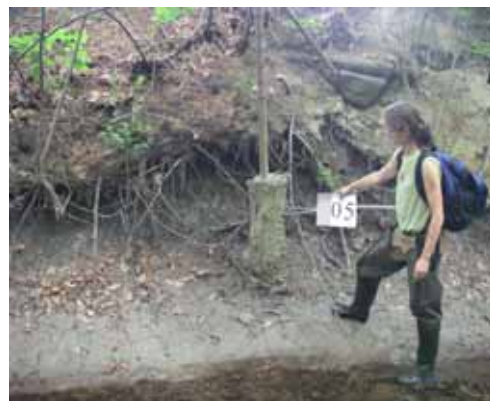
Hanging fencepost shows severe bank erosion near Station 1.

Severe bank erosion was noted in the eastern portion of the watershed in both the habitat, stream corridor and geomorphology surveys, and at Station 3 (below Payne Road), one rock bag sample was 60% buried in sand in the month that it was placed in the stream. The 2010 geomorphology study also identified several streambank erosion and floodplain incision problems caused by drainage pipes discharging stormwater runoff into the channel and on the floodplain.

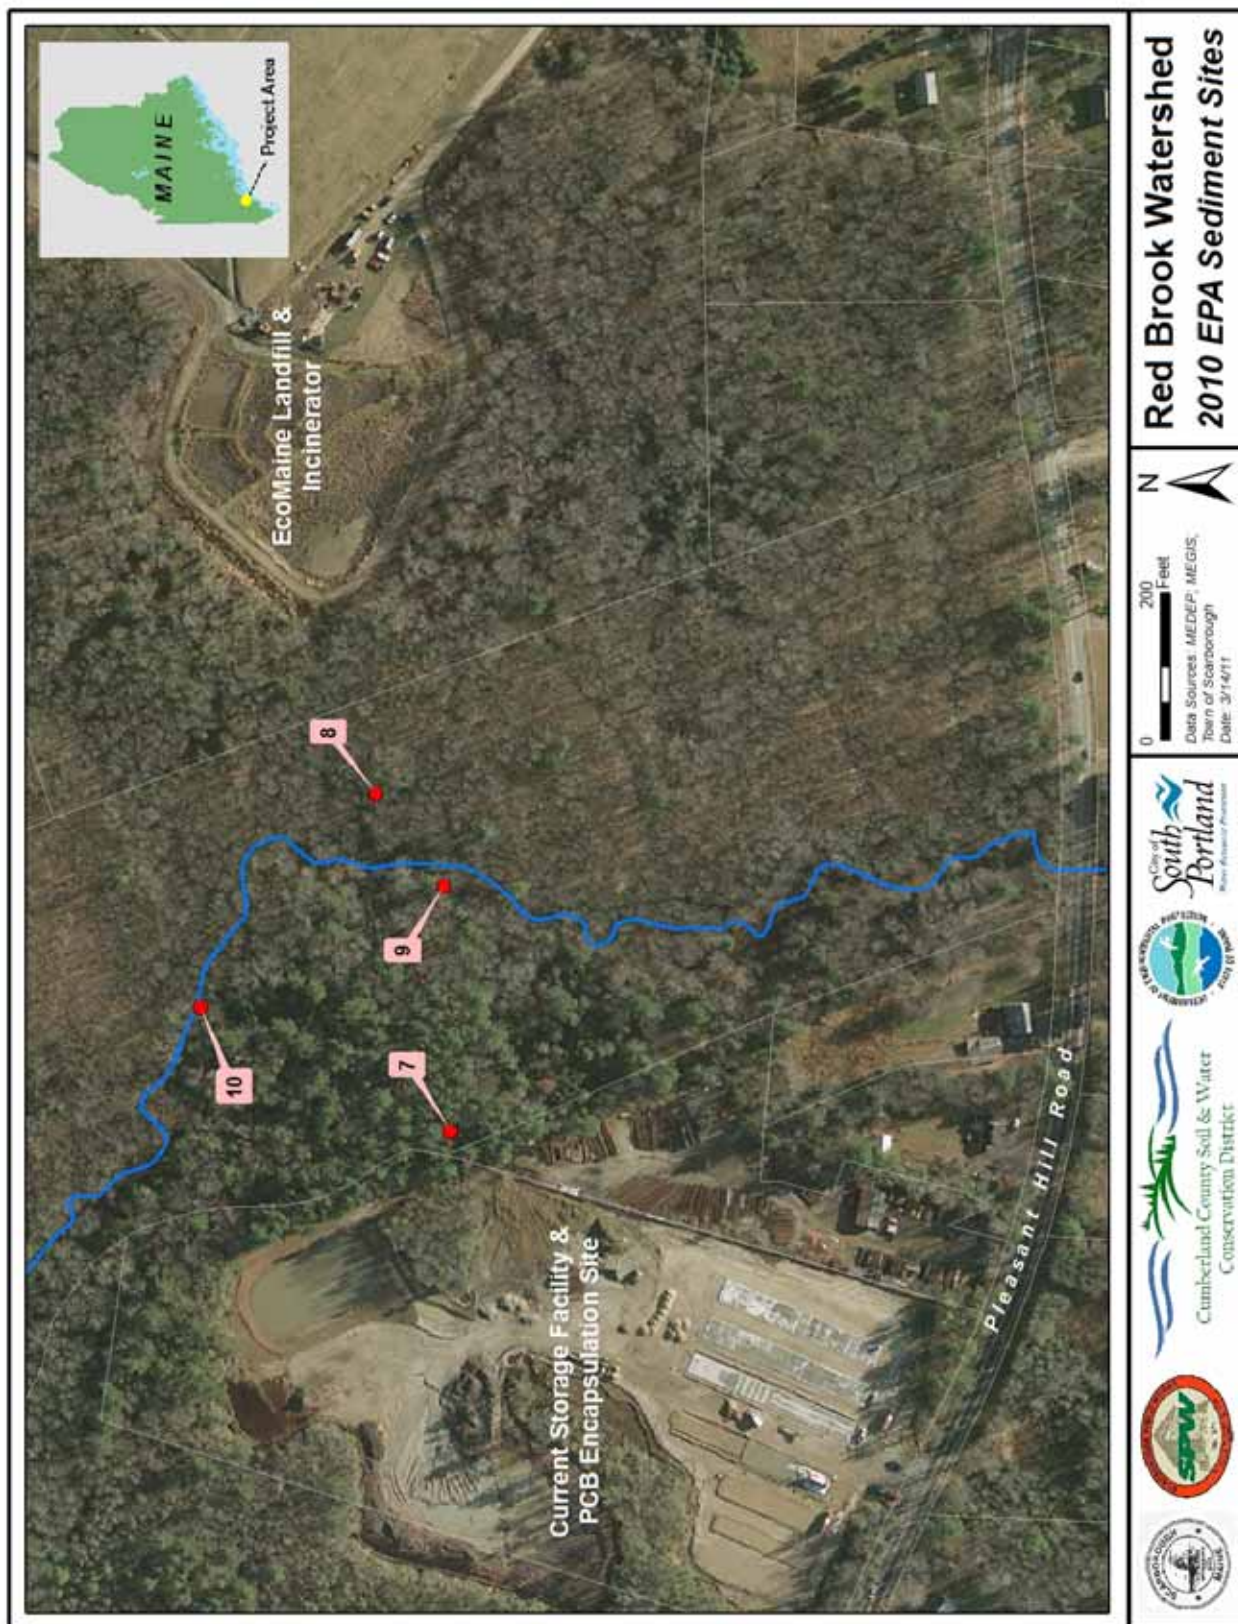
Figure 8. EPA Sediment Sites.

EPA conducted a sediment study in 2010 to further investigate the concerns raised by the public about PCB sources to Red Brook. Four drainage channels extending from Red Brook to the ecomaine landfill, the Larson-Chapman S.D. Warren landfill and the former salvage yard were identified, and sediment from these channels was collected and analyzed for PCBs. (Figure 8.) EPA did not detect PCBs at any of the sites. Although this does not completely rule out the possibility that one or more of these sites are/were sources of PCBs to Red Brook, it does build the case that there is no ongoing PCB contamination to the stream and that the primary source has been addressed.

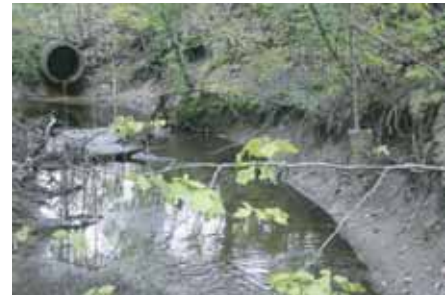
As a result, the highly impervious areas in the lower part of the watershed have changed stream flows by directing large volumes of runoff directly to the stream. Some of the stormwater discharges directly into the stream in outfall pipes (see photo above). Other outfalls flow into road ditches, which in turn flow into the stream. Outfalls from several detention ponds drain onto Red Brook's floodplain. Floodplain and streambank erosion were observed below several of these outfalls.

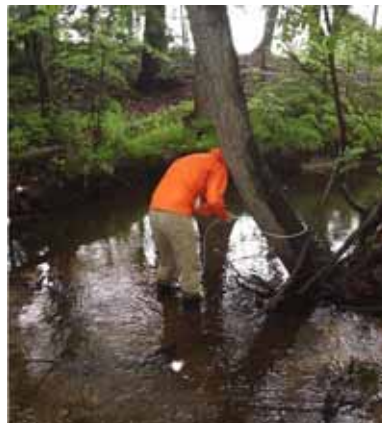
Project consultants collected water quality data at 3 datasondes stations

Overall, the data showed high levels of dissolved oxygen at all three sites. All measurements exceeded the stream's required Class C limits. The lowest measured values were near 7 mg/L, which is the limit for Class B stream in Maine. Of the three sites, the Site 3 (just below Payne Road) had the lowest dissolved oxygen values. The DO minimum at this site was 6.6 mg/L with 393 readings below 7 mg/L. Dissolved oxygen measurements at this station also recorded the highest temperatures.

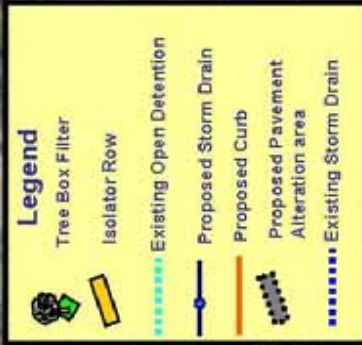
# SITE 103

### Site Characteristics:

- Impervious Area = 1.5 acres +/-
- Existing Stormwater Management System – Yes (no catch basins, only piping for roof drain conveyance)
- Stormwater Infrastructure Ownership – Private
- Roof and pavement tributary to existing dry detention basin.

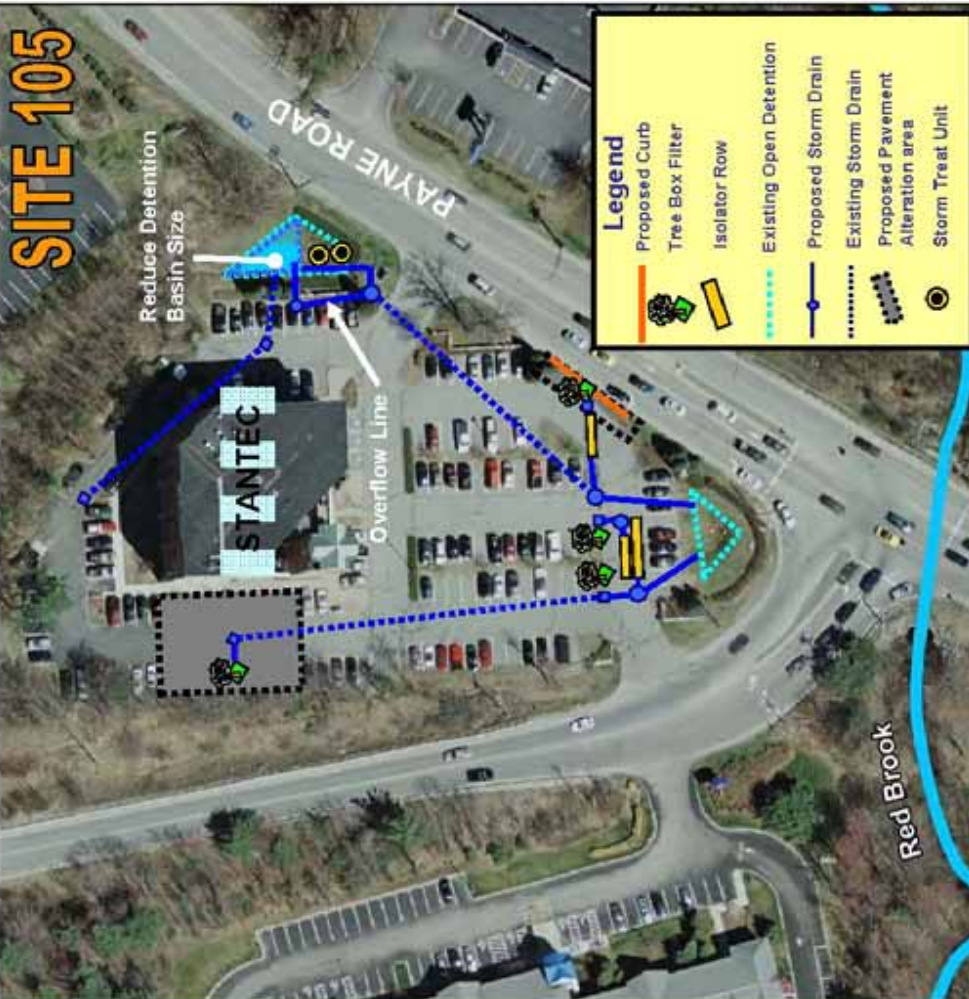
**Site Characteristics:**  
 Impervious Area = 1.9 acres +/-  
 Existing Stormwater Management System – Yes  
 Stormwater Infrastructure Ownership – Private  
 Root and pavement tributary two small existing detention basins

**Proposed Retrofit Summary:**  
 Install four tree box filters to provide water quality treatment for the south and west portion of the site. Treated flow and untreated overflow for major storm events will be conveyed through an isolator row. Discharge from the isolator row will be conveyed to the existing detention basin and released to the Town storm drain system.  
 Reduce the size of the easterly existing detention basin and install two Storm Treat units to provide water quality treatment for the building and the northerly and easterly portions of the parking area.

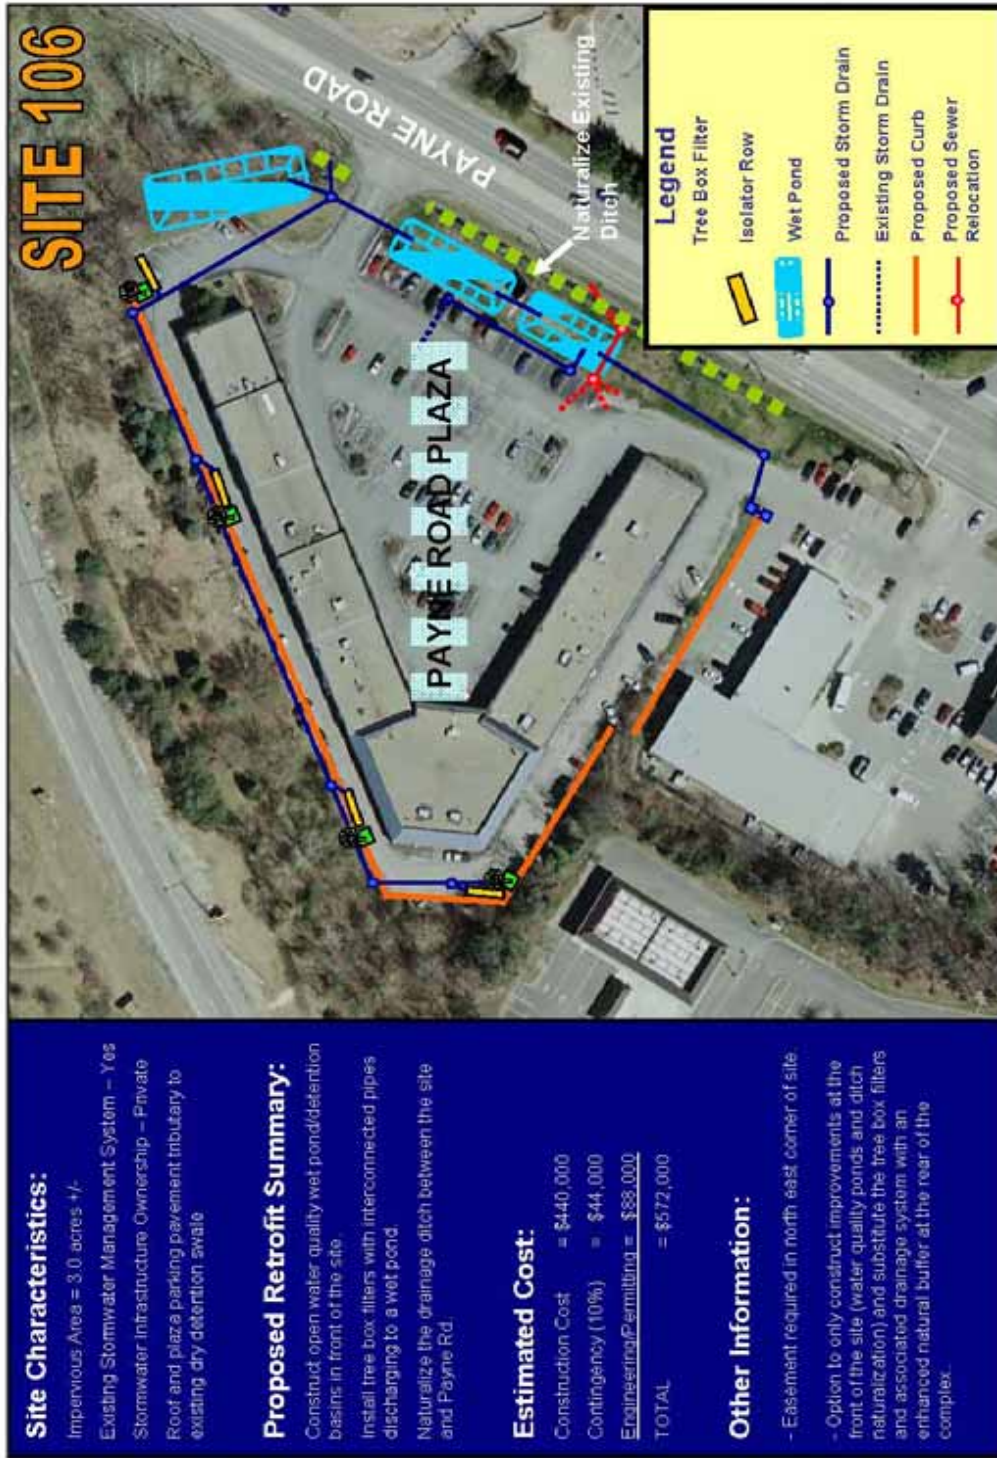
**Site Characteristics:**

- Impervious Area = 3.0 acres +/-
- Existing Stormwater Management System – Yes
- Stormwater Infrastructure Ownership – Private
- Roof and plaza parking pavement tributary to existing dry detention swale
