**MAINE HEALTHY BEACHES PROGRAM  
SUMMARY REPORT OF ENHANCED MONITORING AND  
POLLUTION SOURCE TRACKING EFFORTS IN  
THE WILLARD BEACH WATERSHED SOUTH  
PORTLAND, MAINE  
2012-2019**

**July 2020**

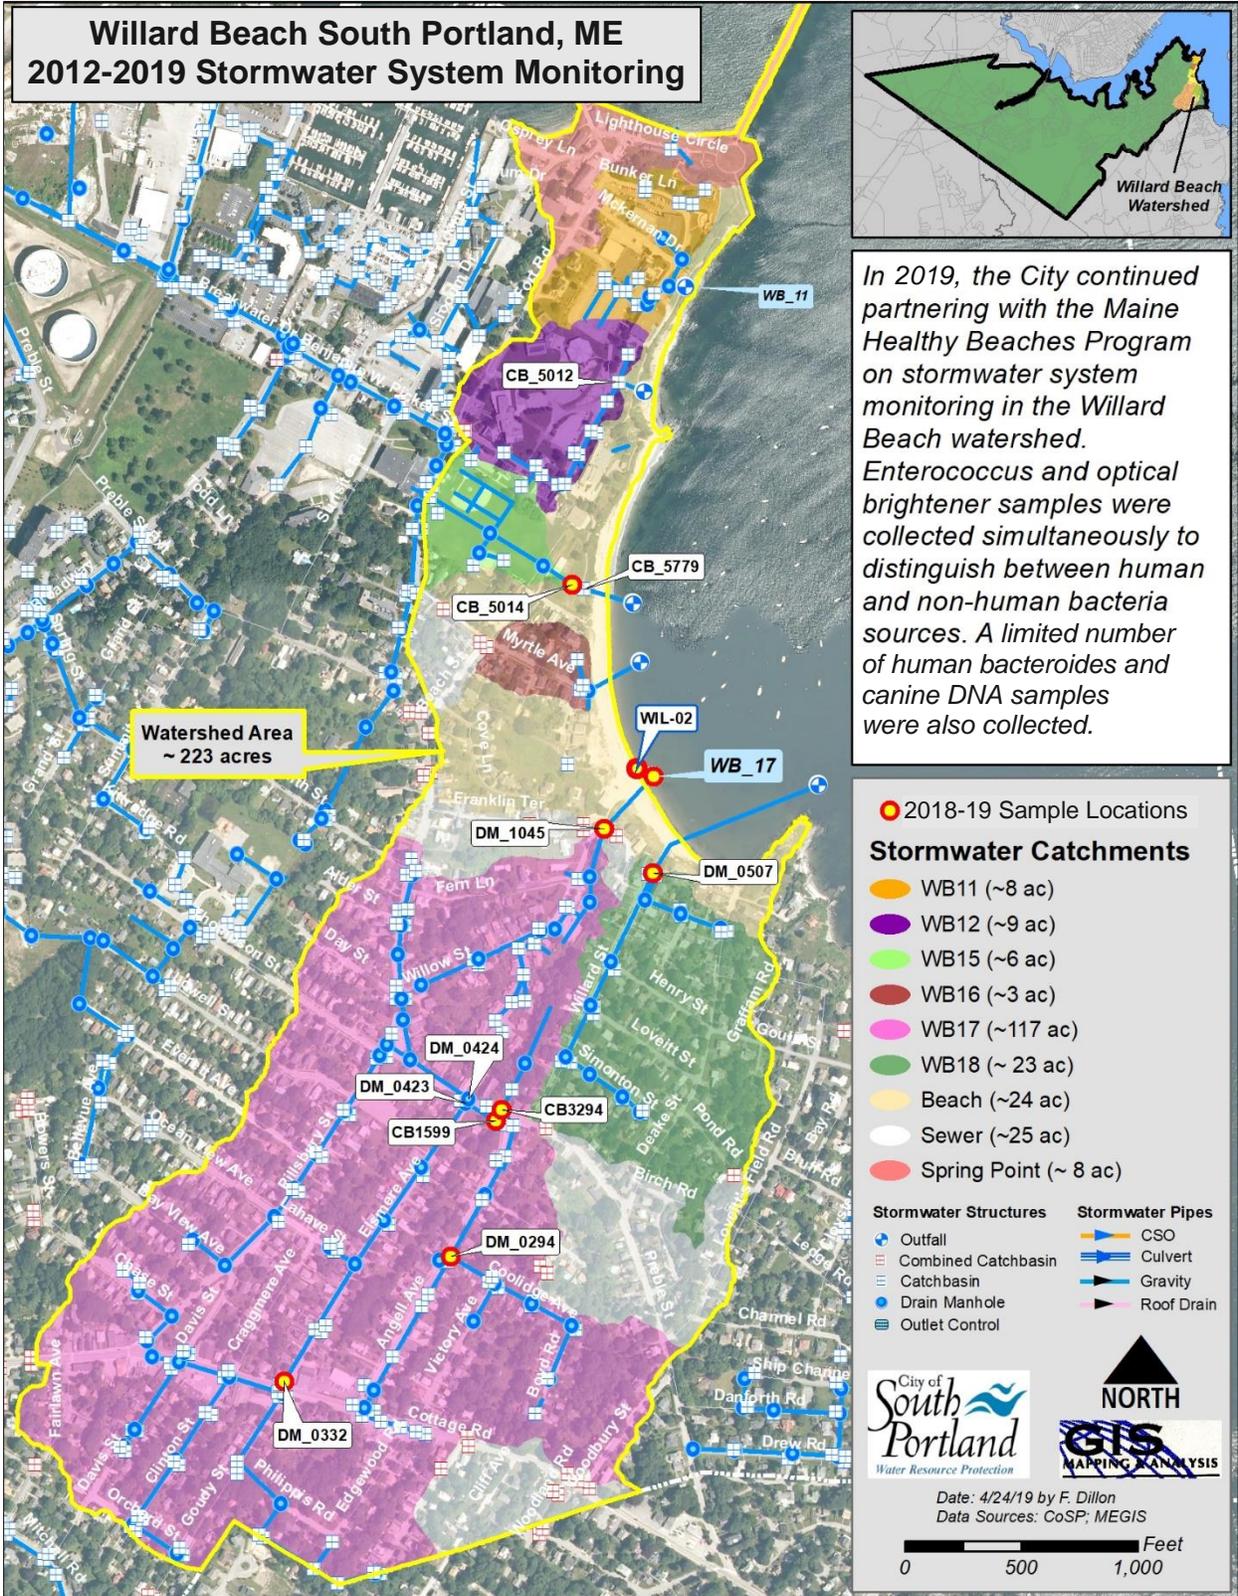
Figure 1. Willard Beach stormwater drainage area (yellow outline) and stormwater sampling sites/structures monitored by City of South Portland Water Resource Protection Department (2012-2019).

There are six stormwater outfalls that discharge directly to the beach and drain stormwater from ~ 1 km<sup>2</sup> of residential, commercial, and institutional areas. Of particular concern are catchments WB15, which collects stormwater from the SMCC athletic fields, and WB17 and WB18, which collect stormwater from a predominantly residential area with several interspersed commercial enterprises. Outfalls WB11, WB12, and WB16 typically have very low discharge volumes and were not consistently monitored as part of this study (Figure 1).

All problematic sites/structures identified in the risk matrix were located within sub-catchment WB17 (pink sub-catchment in Figure 1). This is the largest sub-catchment in the watershed. Problematic locations were primarily located along Preble St. between Elsmere Ave. and Angell Ave. as well as a few upland structures draining to this region (Figure 1). Geomean values for all structures highlighted in Table 2 were greater than the 2012-2019 watershed-wide ENT geomean, and average OB values for four structures (CB3294, CB1599, DM0332, DM0294) tested above the watershed OB mean (Figures 4-5). Three sites tested positive for human-sourced fecal contamination using canine detection and MST (WB17, CB3294, DM0294) (Tables 2, A2).

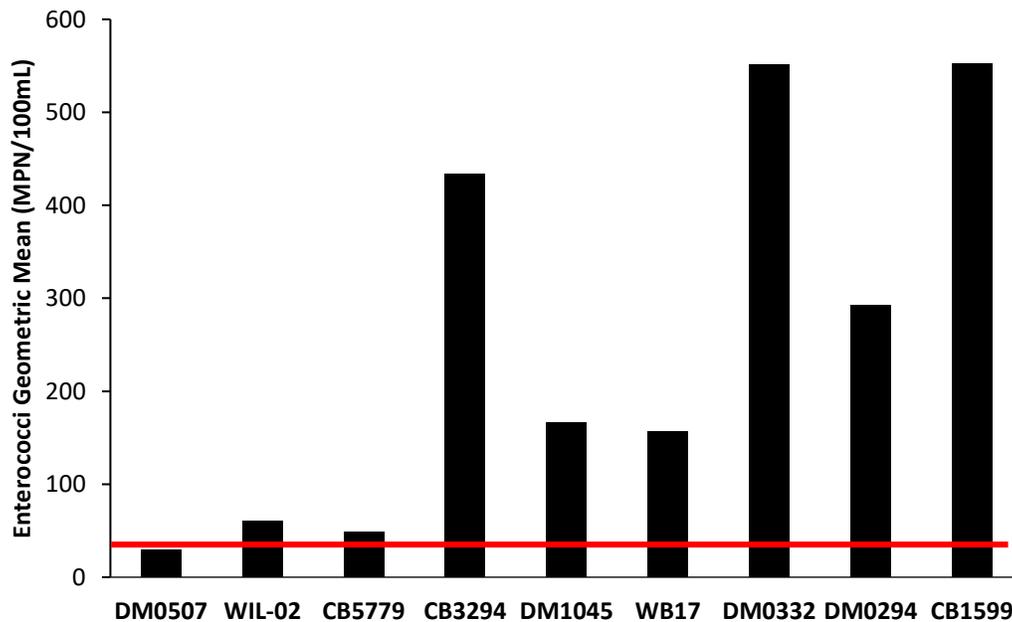
**Figure 2. ENT geometric mean (MPN/100mL) concentrations for sites/structures monitored in the Willard Beach watershed from 2012-2019 (monitoring locations with five samples or greater included). Red solid line indicates Maine’s EPA-approved ENT geometric mean safety threshold of 35 MPN/100mL for fresh water.**

Combining data from 2012-2019, the site specific ENT geometric mean<sup>3</sup> results ranged from 29-552 MPN/100mL and from 11-120 µg/L for mean OBs.<sup>4</sup> All monitoring locations except DM0507 exceeded the US EPA-recommended ENT geometric mean safety threshold of 35 MPN/100mL for fresh waters, while two structures (CB3294 & CB1599) exhibited OB mean concentrations above 100µg/L, the value MHB considers as a lower threshold or “red-flag” for OB results with the potential for human wastewater contamination.<sup>5</sup> The combined ENT geometric mean value for all locations (120 MPN/100mL) was almost 3.5 times greater than the EPA-recommended geometric mean safety threshold. The combined OB mean value of 50 µg/L was well below the 100 µg/L threshold (Table 1, Figures 2-3).<sup>6</sup>

Structures CB3294, DM0332, DM0294, and CB1599 demonstrated consistently elevated geomean ENT and mean OB levels over multiple seasons, suggesting the potential for human-sourced fecal contamination at these locations. Mean OB values were relatively low (less than 50 µg/L) for approximately half of sites consistently monitored (2012-2019), suggesting non-human sources (wildlife, pets) may be the principal contributors to stormwater bacterial pollution at these locations. However, human sources cannot be ruled out, as optical brightener concentrations varied between monitoring locations, with mean values for two routinely monitored structures (CB3294, CB1599) and two infrequently monitored structures (DM0423, DM0424)<sup>7</sup> exceeding the 100 µg/L threshold (Table 1, Figures 2-3).

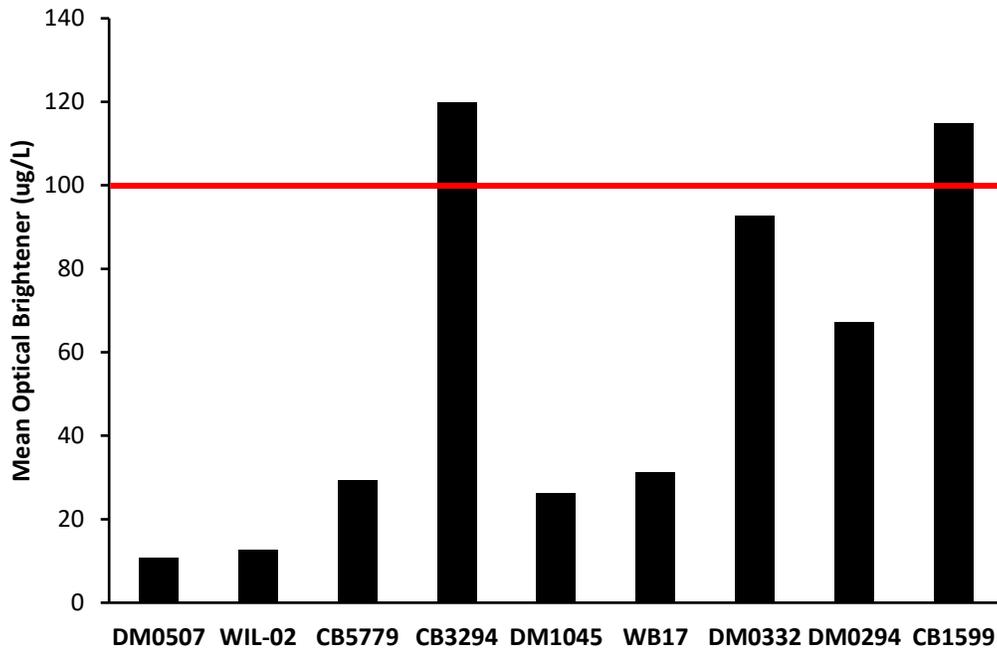
**Figure 3. Mean OB ( $\mu\text{g/L}$ ) concentrations for sites/structures monitored in the Willard Beach watershed from 2012-2019 (monitoring locations with five samples or greater included). Red solid line indicates the OB lower threshold level considered by MHB as a “red-flag” for potential human wastewater contamination (100  $\mu\text{g/L}$ ).**

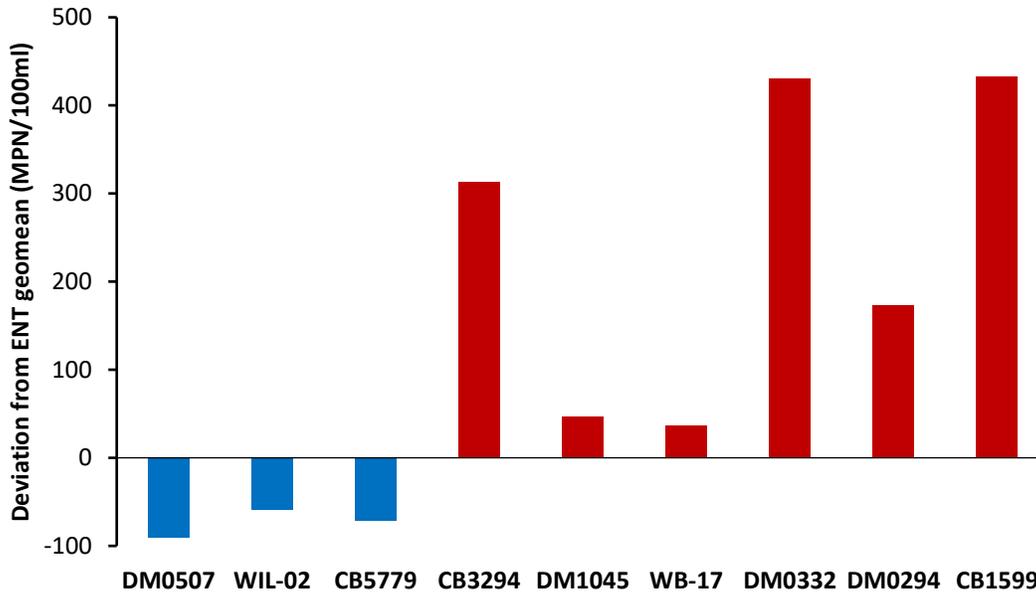
**Figure 4. Deviations from the 2012-2019 combined ENT geometric mean (120 MPN/100mL) for stormwater sites/structures. Bars above X-axis indicate monitoring locations with 2019 ENT values greater than the 2012-2019 combined geomean and bars below X-axis represent values lower than the combined geomean (Note differences in sample size, Table 1).**

Six structures (CB3294, DM1045, WB17, DM0332, DM0294, CB1599) positively deviated from the watershed ENT geomean (120 MPN/100mL) and 4 of those structures (CB3294, DM0332, DM0294, and CB1599) positively deviated from the watershed-wide OB mean (50  $\mu\text{g/L}$ ), suggesting human-sources are potentially contributing to elevated ENT levels at these locations (Figures 1, 4-5).

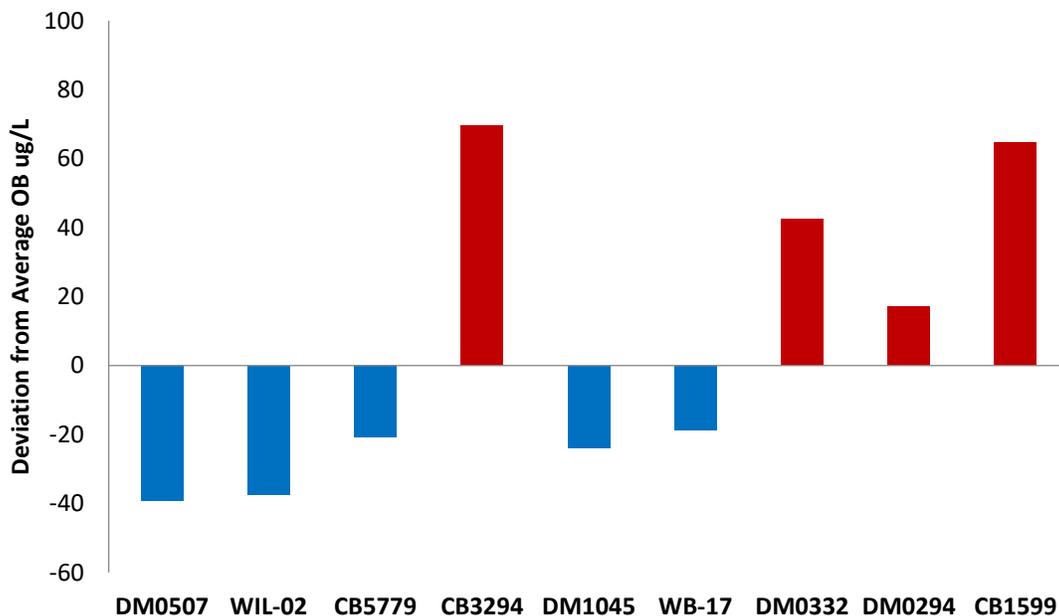
**Figure 5. Deviations from the 2012-2019 combined OB mean (50  $\mu\text{g/L}$ ) for stormwater sites/structures. Bars above X-axis indicate monitoring locations with 2019 OB mean values greater than the combined 2012-2019 average value and bars below X-axis represent those lower than the average value (Note differences in sample size, Table 1).**

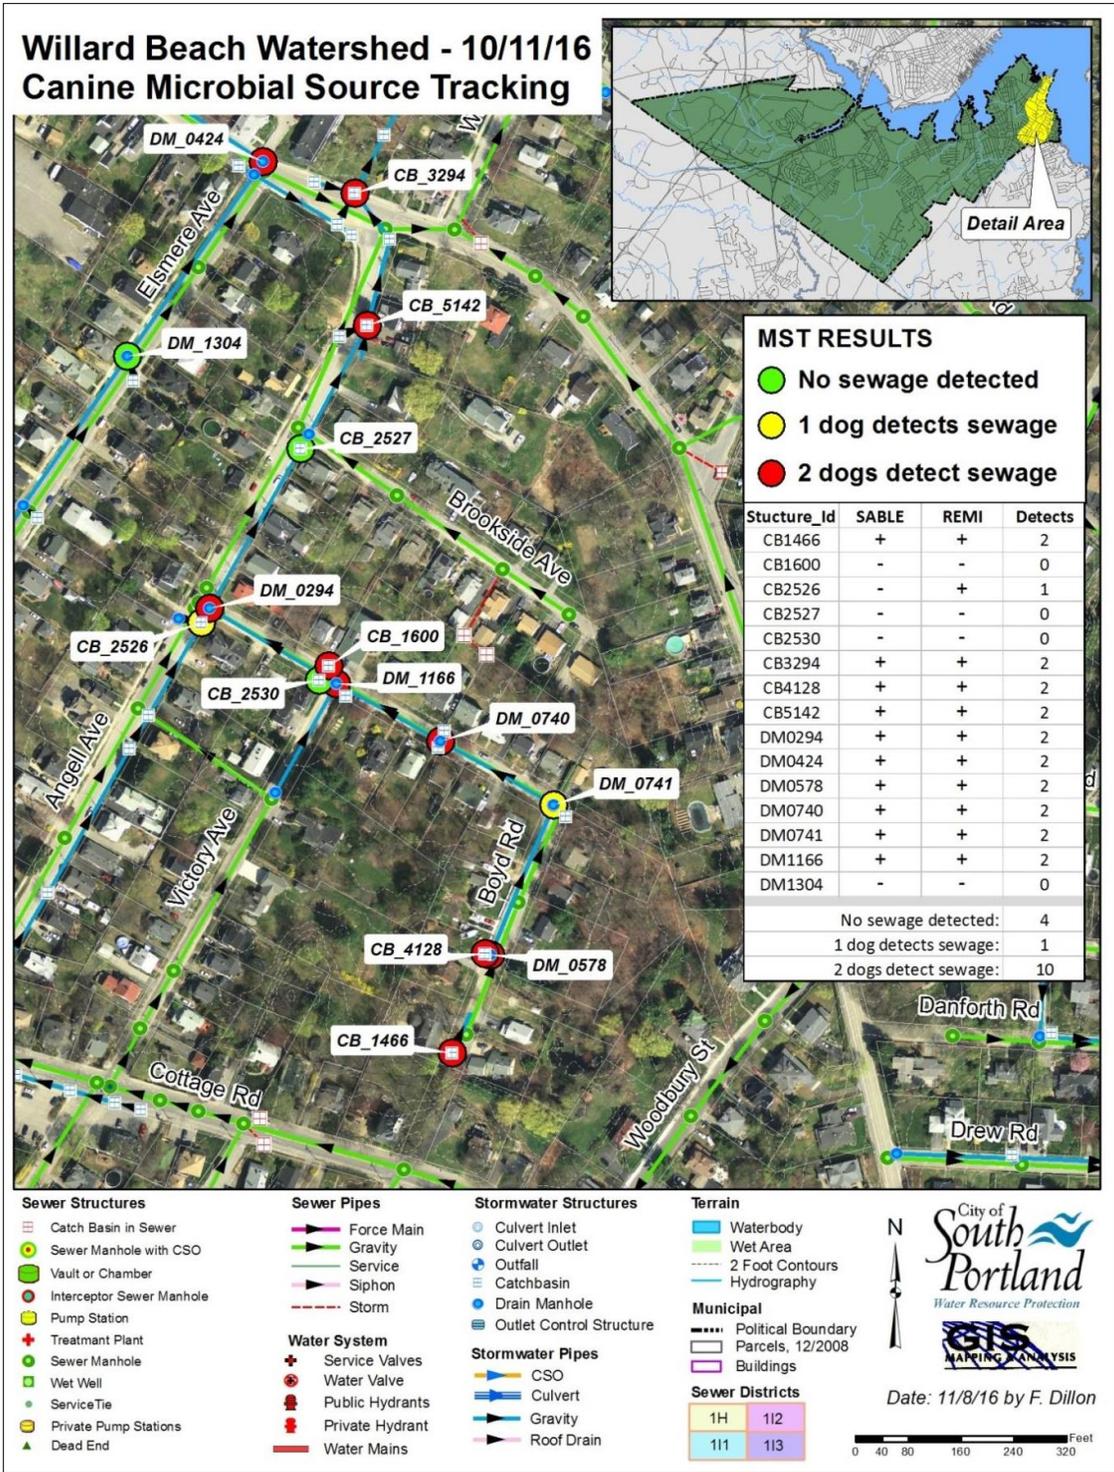
Figure 7. Willard Beach canine source tracking results (October 2016).

Canine detection efforts were not conducted in 2019. Canine detection efforts were conducted in 2014 and 2016. It is useful to perform conventional ENT monitoring in conjunction with canine detection work to further determine potential source(s) of bacterial contamination. Elevated bacteria in the absence of human-source detections may indicate another mammalian source or possible regrowth in the stormwater system. ENT sampling was paired with the canine detection efforts when possible, as indicated below. In 2014, six of the 10 visited structures were sampled for ENT in conjunction with canine detection and none of those exceeded the EPA threshold of 104 MPN/100mL. Of the 10 structures tested in 2014, at least one canine detected human sewage at six locations and both canines detected human sewage at the remaining four. Canine work in 2016 focused primarily on structures upland of those tested in 2014 and did not include ENT monitoring. Of the 15 structures tested in 2016, canines detected no sewage at four structures, one canine detected sewage at two structures, and both canines detected sewage at the remaining nine structures (Figures 6-8). The widespread detection of human fecal contamination by both canines in the WB17 sub-catchment suggests contamination in the separated stormwater system may be originating from nearby leaking sewer pipes, particularly those co-located with storm drains.

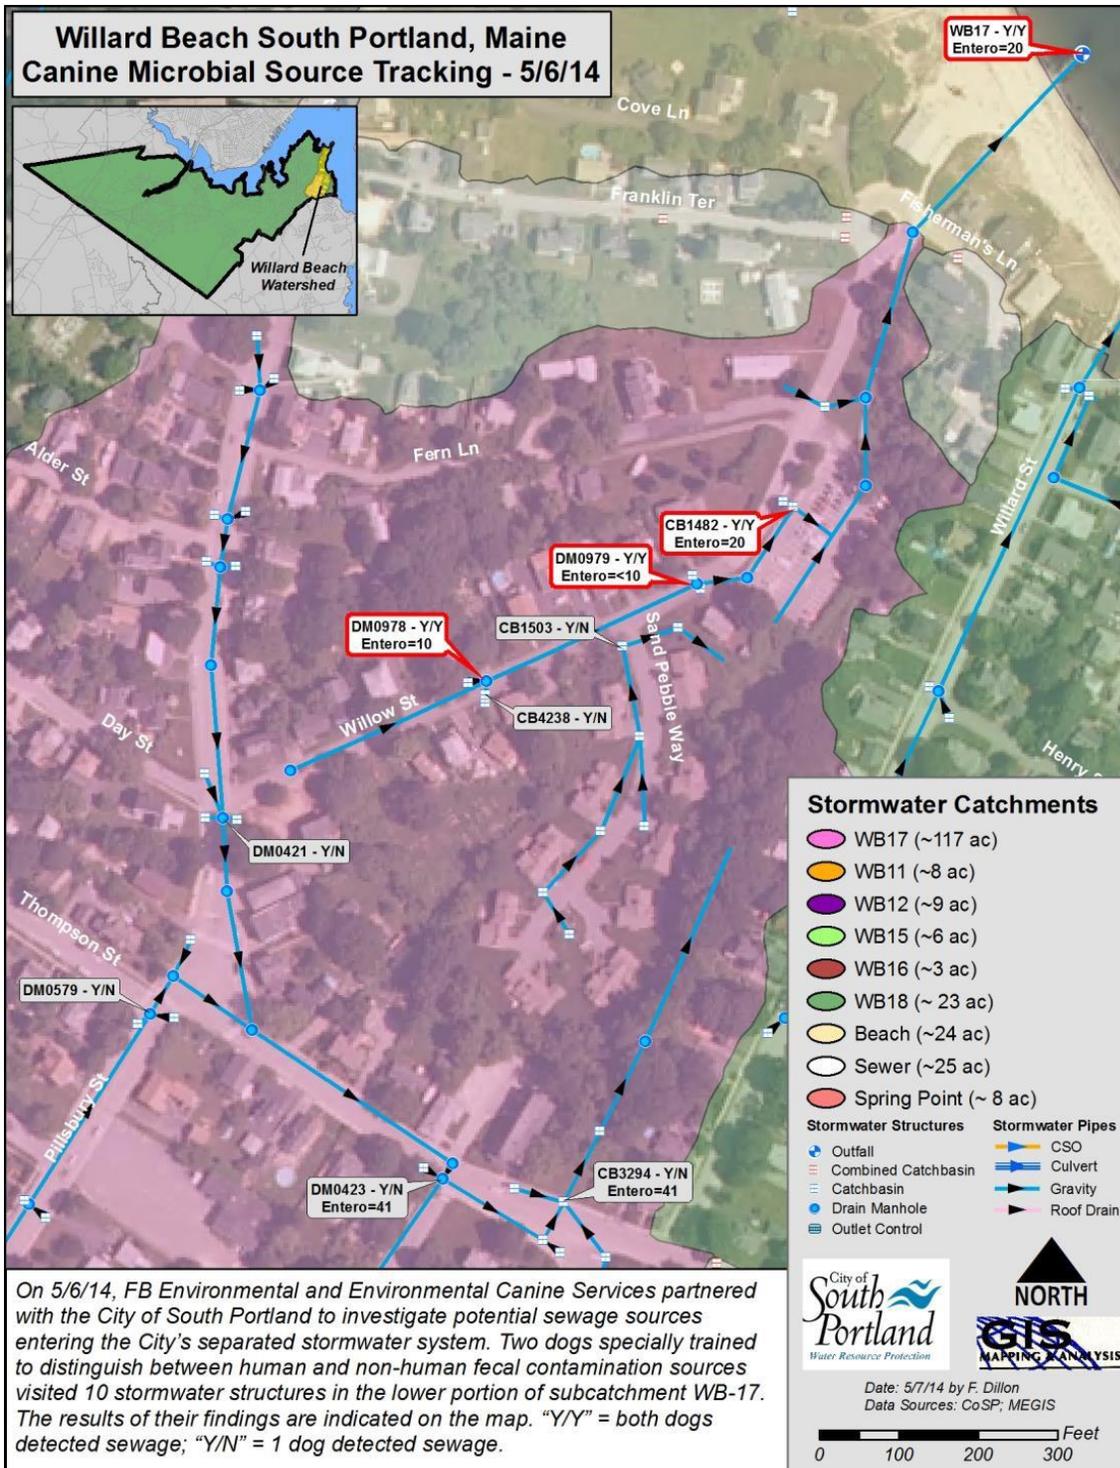
Figure 8. Willard Beach canine source tracking results (May 2014).

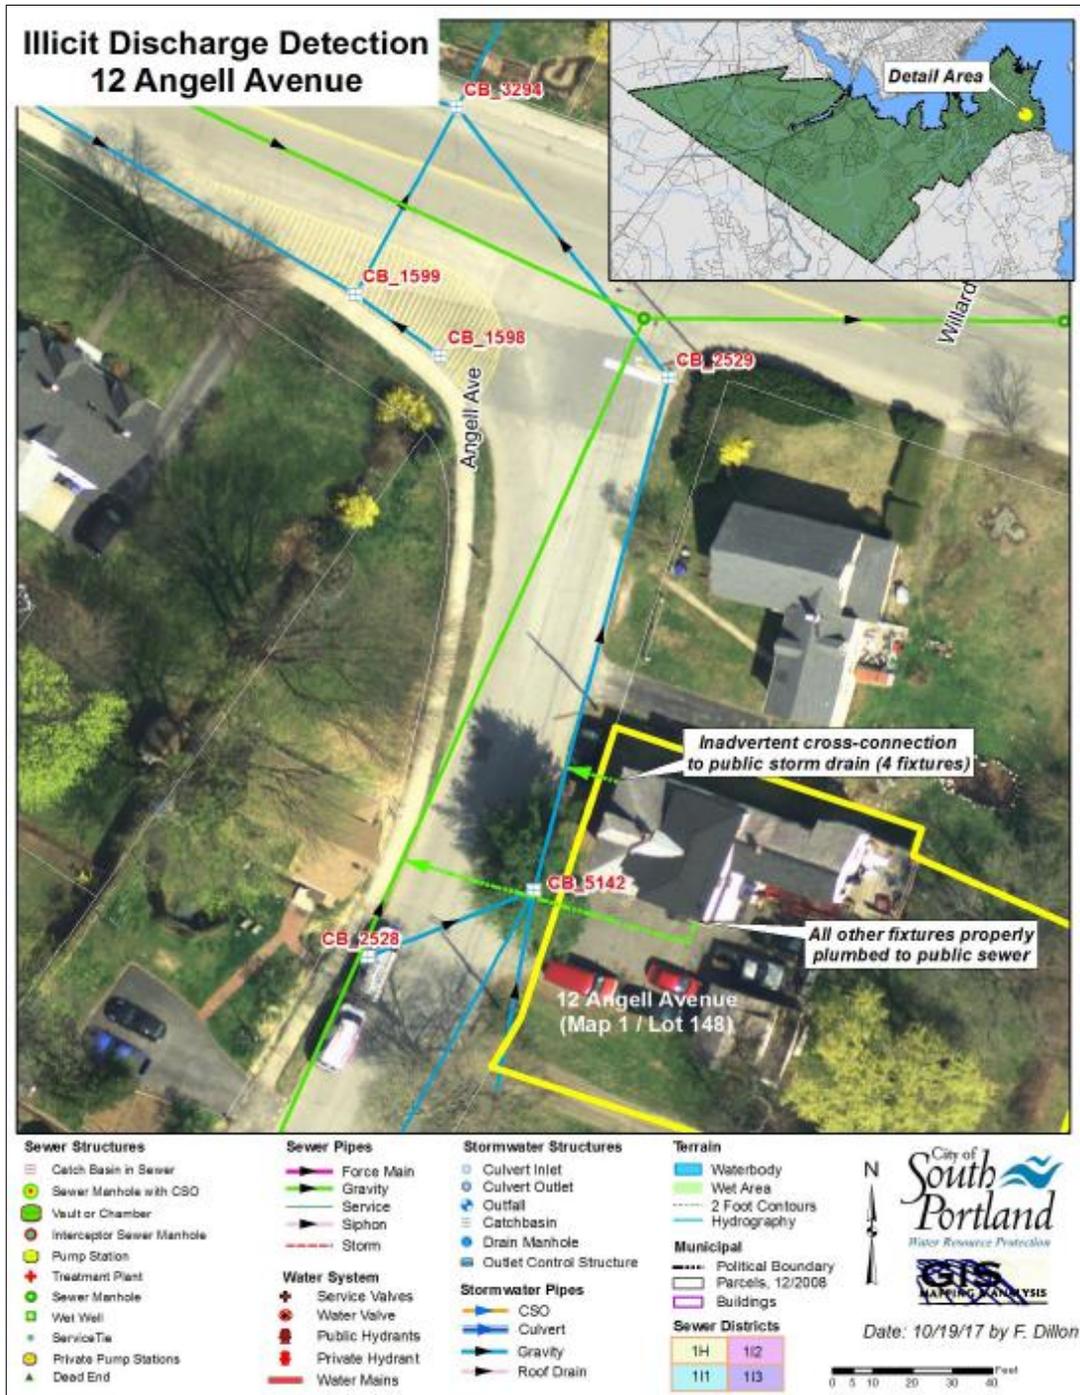
Figure 9. Stormwater system repairs including the removal of a cross connection within the Willard Beach watershed along Angell Ave. in 2017.

Although a cross connection at DM0294 (discharging into CB3294) was repaired in late 2014, consistently elevated ENT and OBs have persisted at structure CB3294 and upland structures for the past several years (Figure 9-10, 12, A1-A2; Table A1). These results, coupled with limited seasonal precipitation, positive human DNA detection at WB17, CB3294, and DM0294 (and upland structures for human-sourced sewage-sniffing dog detections), suggest human sources are still contributing to elevated bacteria in this region. Using these results to guide CCTV and dye testing efforts, the City successfully identified and remediated an inadvertent cross connection between a private residence's internal plumbing and the City's stormwater system in 2017 (Figures 9-10). Although another human source has been removed, elevated bacteria levels continue to persist in this sub-catchment.

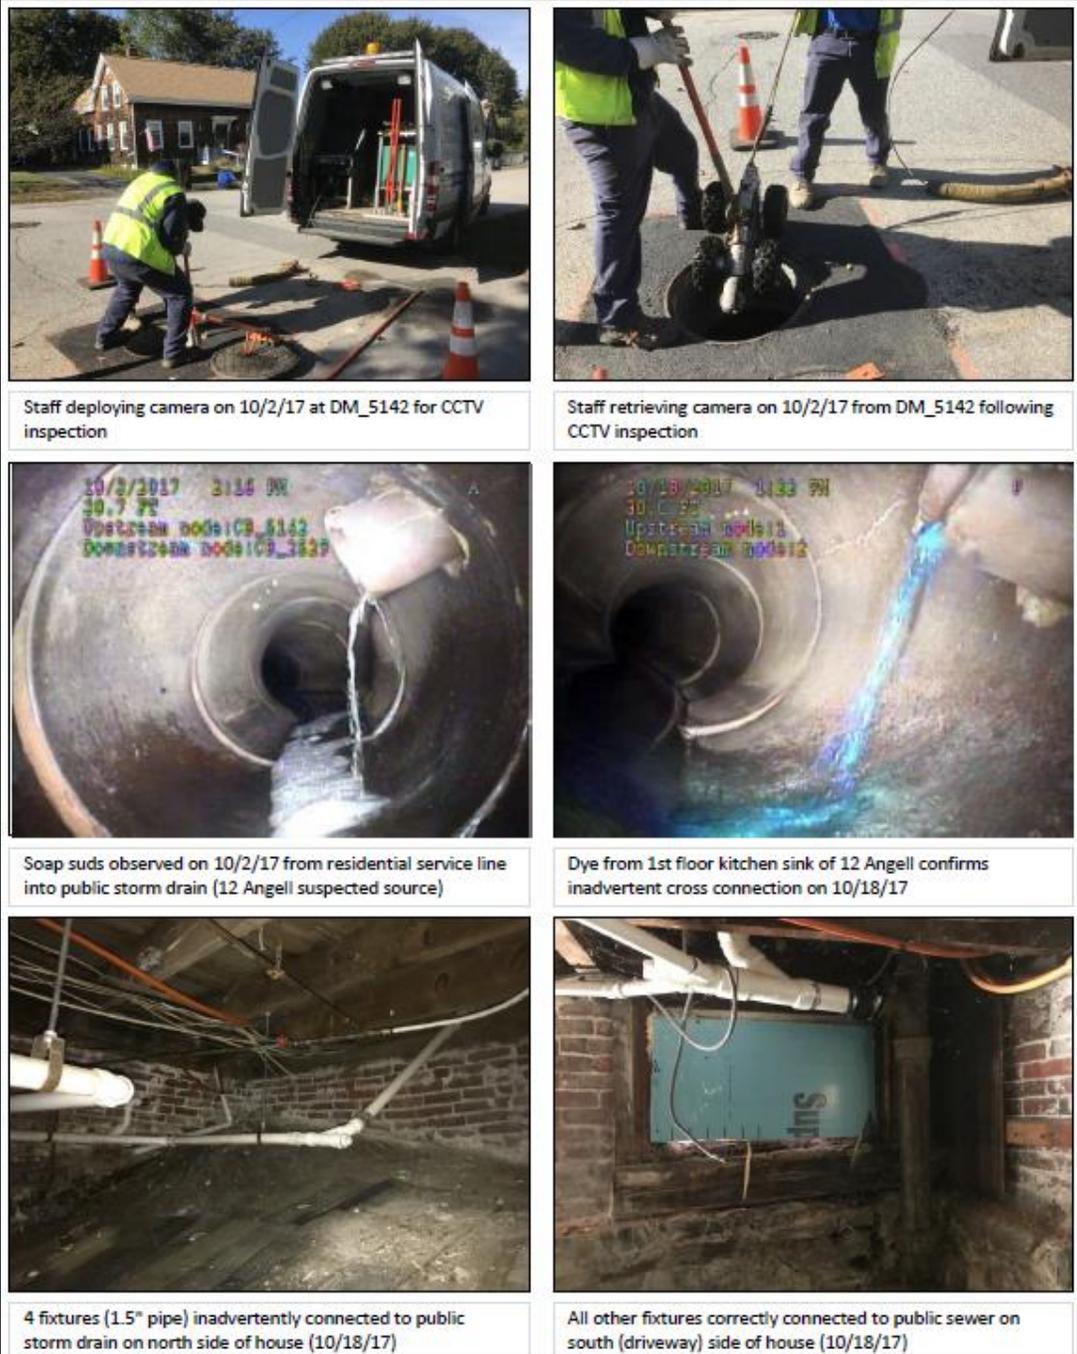
**Figure 10. Detailed identification and repair efforts for the removal of a cross connection within the Willard Beach watershed along Angell Ave. in 2017.**

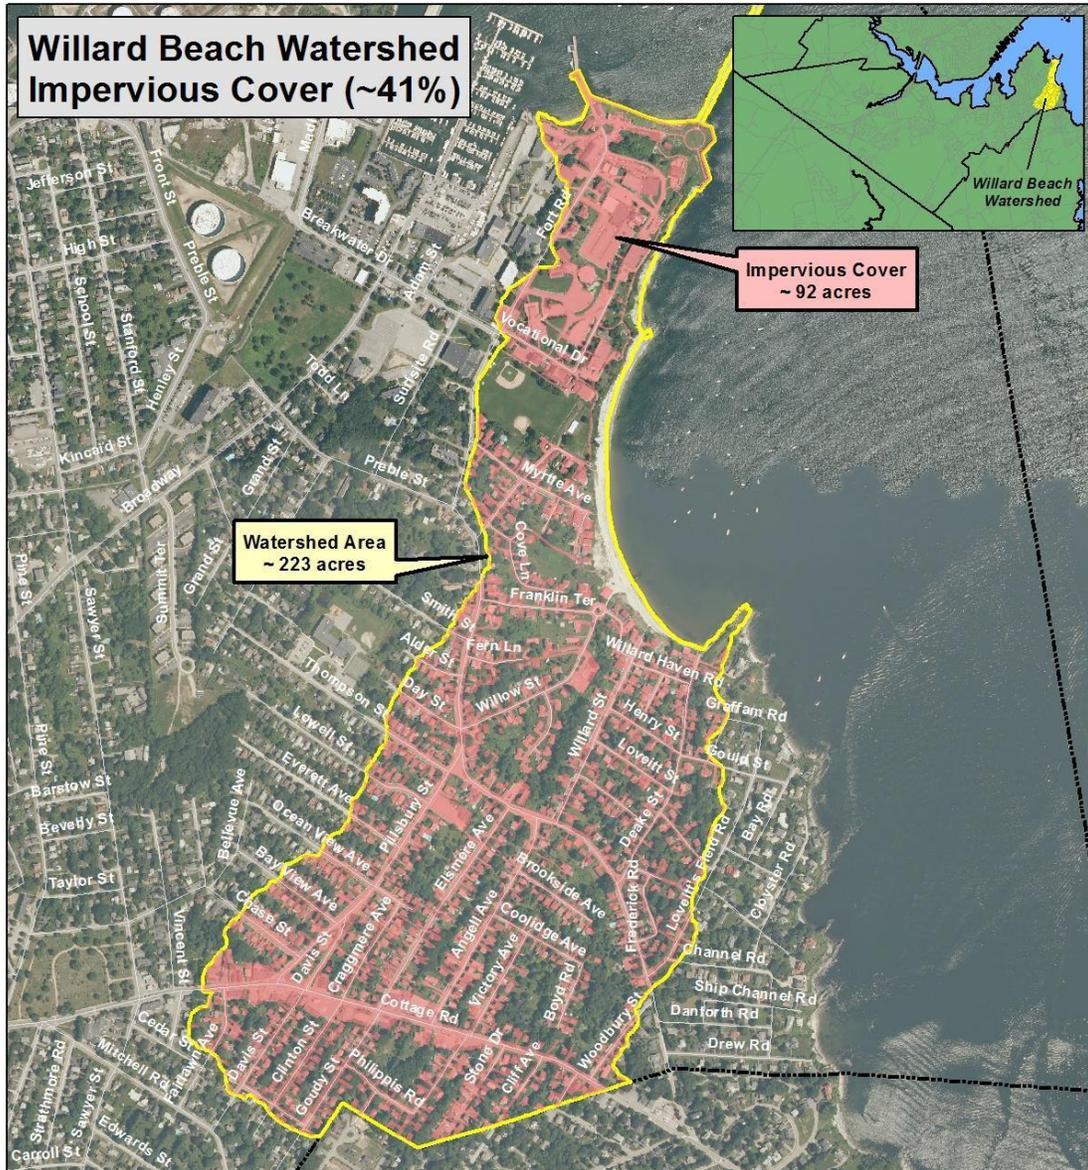
**Figure 11. Willard Beach watershed drainage area (yellow line) and % impervious coverage.**

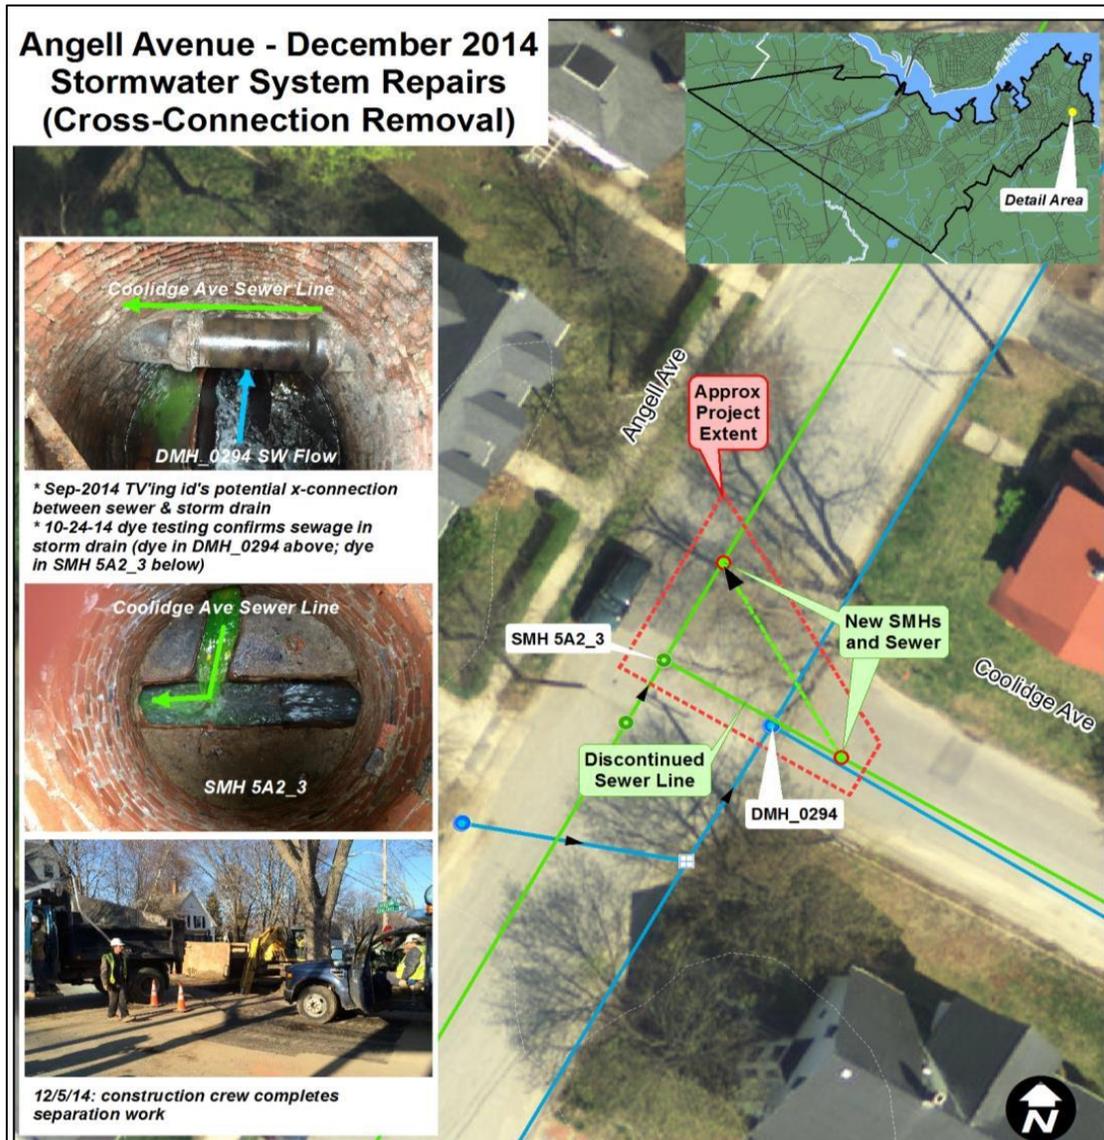
Figure 12. Stormwater system repairs including the removal of a cross connection within the Willard Beach watershed along Angell Ave. (Dec. 2014).

Subsequent dye testing by City staff identified and eliminated an illicit cross connection between the sewer and stormwater infrastructure at site DM0294 (Figure 12). A recent review of the TV inspection videos also identified several residential foundation drain laterals connected to the City’s storm drain, though no overt signs of potential sewage were observed. The City will dye test these laterals in 2020 to confirm no potential cross connections exist.

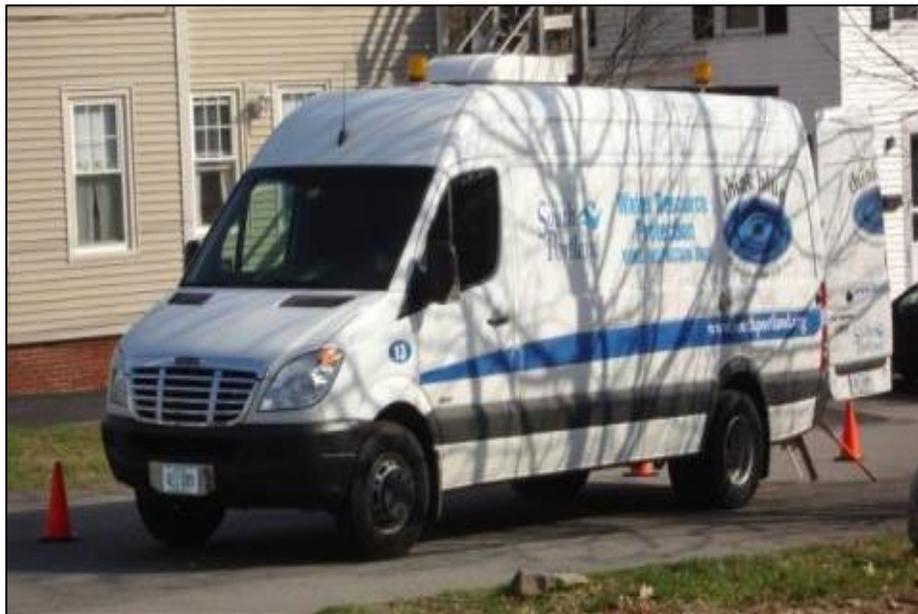
**Figure 13. City of South Portland's closed-circuit television inspection van assessing the condition of the sewer and stormwater systems in the Willard Beach watershed.**

Following the August 2014 discovery of significantly elevated bacteria results in a portion of the separated stormwater system, City staff conducted closed-circuit television inspections in September 2014 to identify potential cross-connections with the public sewer (Figure 13). While no direct connections of sewer service laterals from residences into the separated stormwater system were observed, there were three instances of the public sewer main crossing directly through separated stormwater structures.

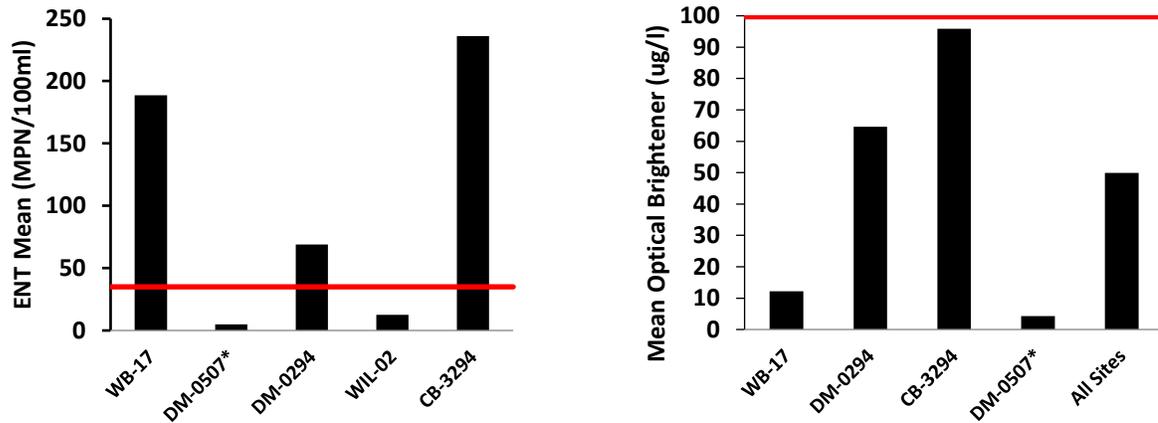
**Figures A1 & A2. 2019 mean ENT (MPN/100mL) and mean OB (µg/L) concentrations for Willard Beach watershed sites. Red line (left) indicates EPA-recommended ENT geometric mean freshwater safety threshold of 35 MPN/100mL. Red line (right) indicates the OB lower threshold level considered by MHB as a “red-flag” for potential human wastewater contamination (100 µg/L).**
