**SOUTH PORTLAND CENTRAL FIRE STATION
& POLICE STATION FACILITIES STUDY**

**684 Broadway & 30 Anthoine St,
South Portland, ME 04106**

CITY OF SOUTH PORTLAND, MAINE

AUGUST 25, 2021

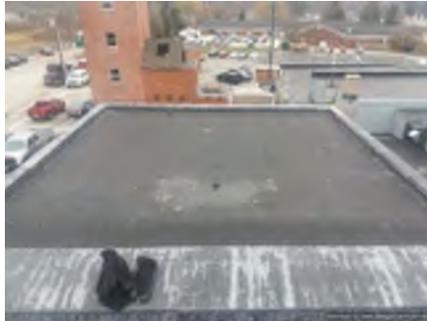
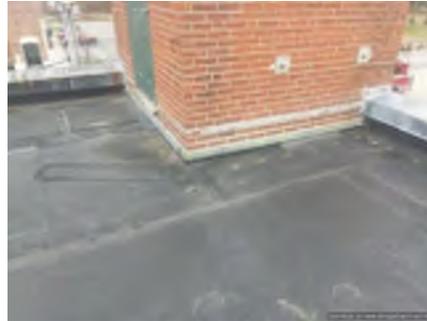
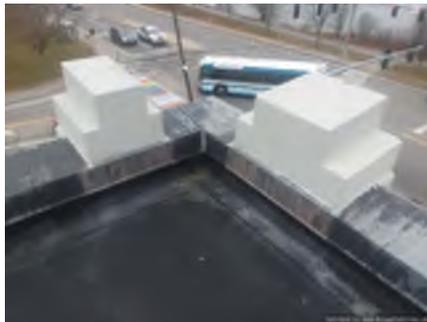
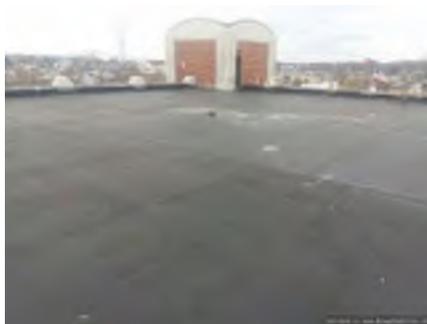
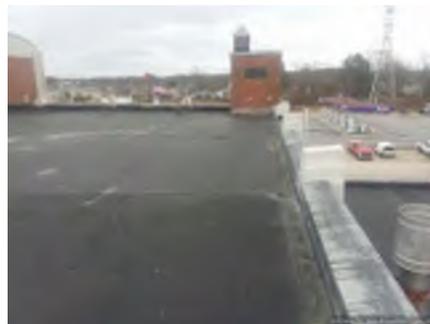
1. The roofing review for the Central Fire Station is based on observations made during a site visit. No specifics are known about the age, or makeup, of the existing roofing materials. Based on conversations it appears that the existing roofing is at least 20 years old. There are a number of repair areas visible for the existing roofing. Options 1, 2, 3 & 4 involve re-use of all/portions of the existing Central Fire Station. For this work, we have considered that any areas retained in these options will be 100% re-roofed. New roof is assumed to consist of R-30 insulation with 0.060 mil EPDM roofing. New insulation to be mechanically fastened and the membrane adhered.

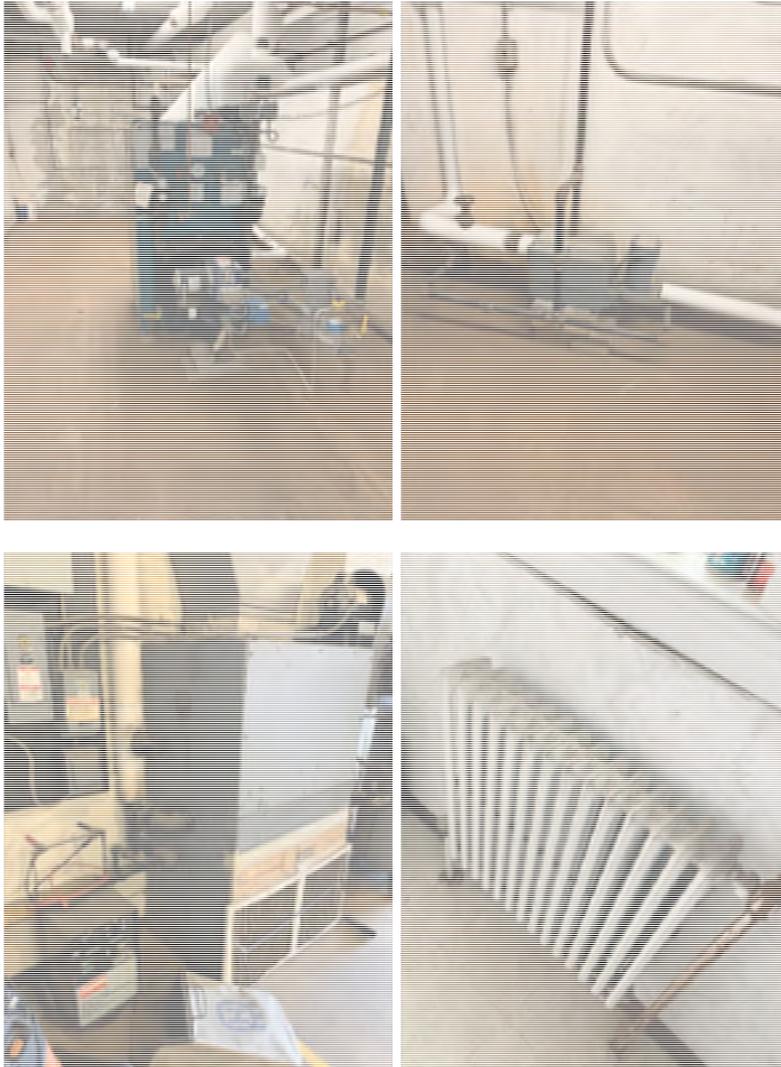
- g. Heating for the first floor Administrative Offices, first floor Bathroom, Dining Room, Lounge, Kitchen, and Bunk Rooms is provided by a combination of cast iron steam radiators and steam finned tube radiation.

- h. Thermal insulation for the steam and condensate piping, where present, consists of fibrous glass with all-service jacket.

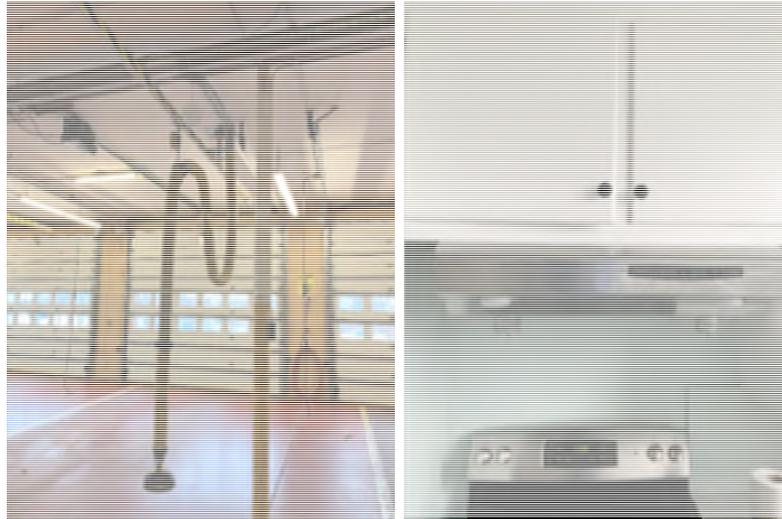
2. Ventilation:
 - a. The Large Apparatus Bay incorporates a vehicle exhaust system with four hose drops for connection to the vehicle exhaust. The system utilizes a utility-set style fan ducted through the exterior wall.
 - b. The small apparatus bays do not incorporate any mechanical ventilation.
 - c. The small bathroom on the lower level adjacent to the large apparatus bays contains an exhaust grille at the ceiling but there does appear to be an operational fan at this area.
 - d. At the upper level of the fire station, the central Dining Room, Lounge, and Bunk Rooms do not incorporate a system of mechanical ventilation. Similarly, the upper level restrooms do not include any exhaust ventilation.

- e. The Kitchen at the upper level contains a recirculating range hood over the electric range. The hood has been outfitted with two fire suppression canisters which are suspended over the cook surface. Both the large and Small Apparatus Bays contain paddle style anti-stratification fans that are manually operated to help circulate stratified heat in the spaces.

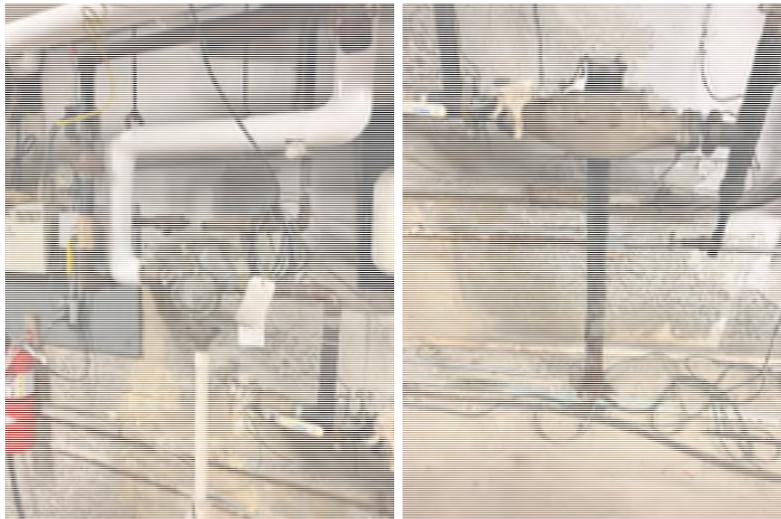
The domestic water service is protected with a Reduced Pressure Zone (RPZ) backflow prevention device, however, the “fast fill” service has no backflow prevention.

The “fast fill” service is metered through the use of an in line water meter. The domestic service appears to contain an electronic flow meter.

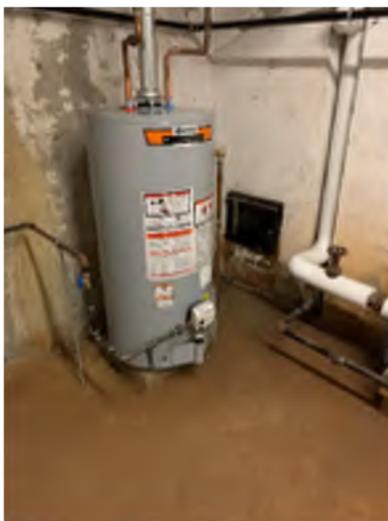
2. Domestic hot water is generated by an electric storage type heater, sized at 40 gallons/40,000 BTU/hr, manufactured by State, located in the basement mechanical room.

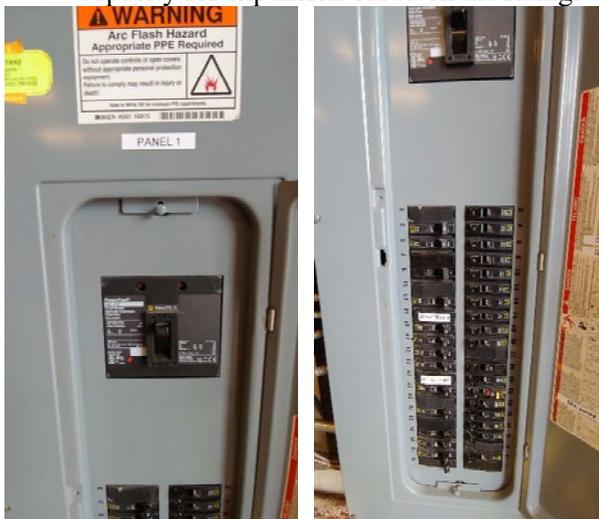
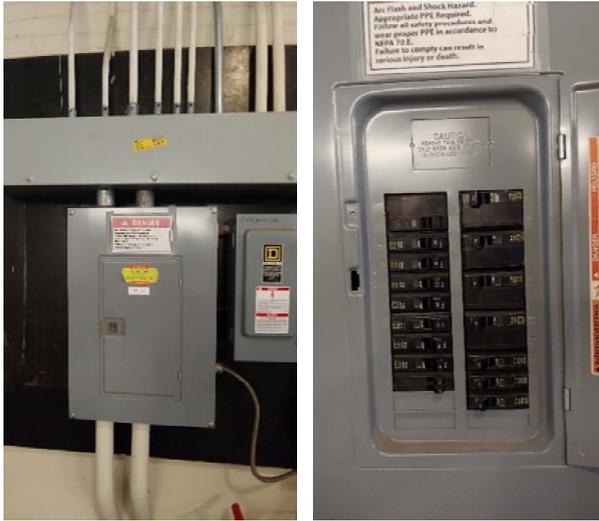
2. The Fire Station has two branch-circuit load centers, both of which are Square D QO series. Panel 1 is located adjacent to the service equipment; it appears to be less than 10 years old but is fully utilized and is located in an area used for vehicle washing, for which it is not suitably rated. Panel 2 is a 20-circuit load center that also appears to have no available capacity for expansion based on the ratings of its branch circuit breakers.

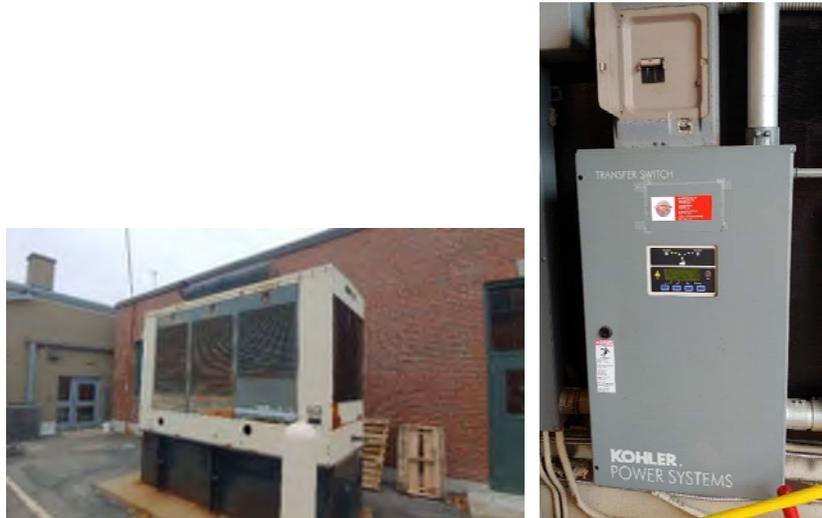
3. A Kohler 230-kW diesel-fueled generator located outside of the fire station provides standby power for the entire fire station building service via an automatic transfer switch, as well as the police Station. The generator does not serve the fire station SCBA compressor.

Power Products Systems, LLC, the local Kohler representative reports that the existing generator was placed in service in January of 1999. The generator is reported to be exercised weekly.

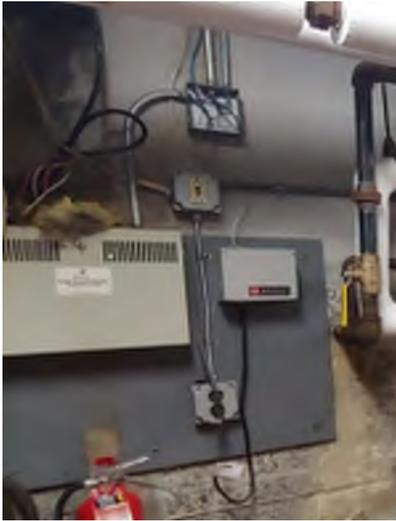
9. Access to the Fire station is controlled by Altronix door controls, card readers, and electric locks. The controller is located in the basement, which is located below the flood plain.

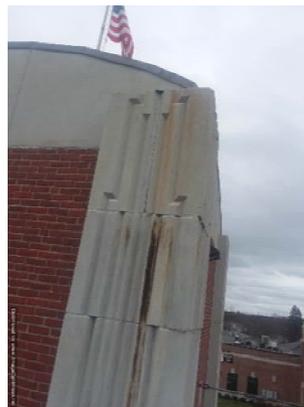
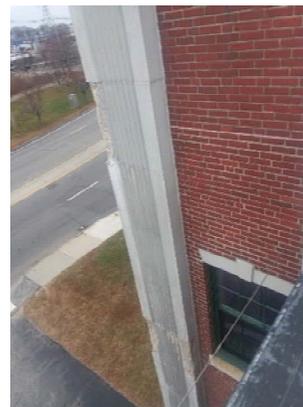
3. The existing concrete façade elements along the Broadway street side of the Central Fire Station exhibit signs of significant deterioration, most likely from water infiltration/freezing. Our understanding is that 8+/- years ago some loose pieces of these concrete elements were falling to the ground. Concern was such at that time that repairs were done to remove any loose pieces and to seal surfaces of the concrete façade components to help inhibit water infiltration. It appears that this work did stop loose pieces from falling but the concrete still needs significant repair, and replacement of at least some sections, to bring the façade back to 'like new' conditions. Our understanding is that any schemes involving reuse of the Central Fire Station space are to involve repair/replacement of the concrete sections to bring them back up to 'like new' conditions.

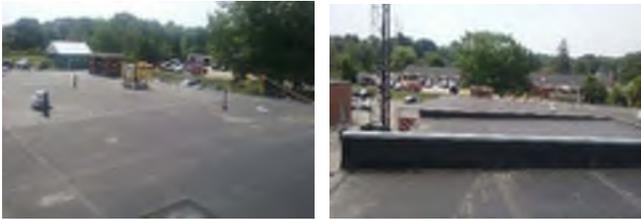
1. The existing roof is surfaced with an EPDM membrane applied over insulation which is mechanically fastened to a metal decking system. The thickness of the insulation was not determined by AEI but could be from a coring sample performed by a roofing contractor. Given the age of the building and the presence of fiberglass batt insulation laid above the interior ACT ceiling system it is likely that only a minimal amount of insulation exists above metal deck/below EPDM membrane.

2. Conversations with Tecta Roofing indicate that the current roofing membrane was added in 2004. Tecta Roofing indicated that no insulation was added as part of the reroofing work in 2004.
3. Existing roofing membrane appears to be in decent condition.
4. Existing roofing seams/seams at patches appear to be in decent condition.
5. A number of small holes/openings in seams were noted.

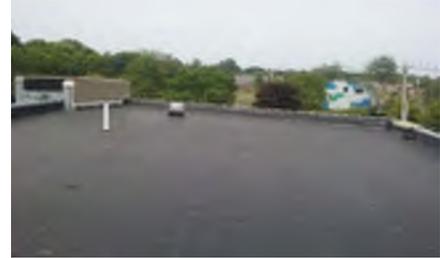
3. Existing roofing membrane appears to be in decent condition.

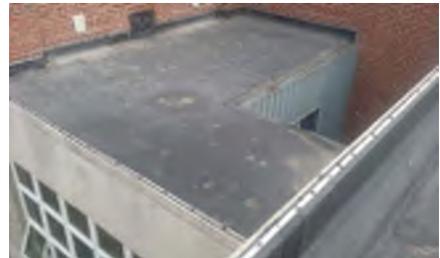
4. Existing roofing seams/seams at patches appear to be in decent condition.

5. A number of small holes/openings in seams were noted.

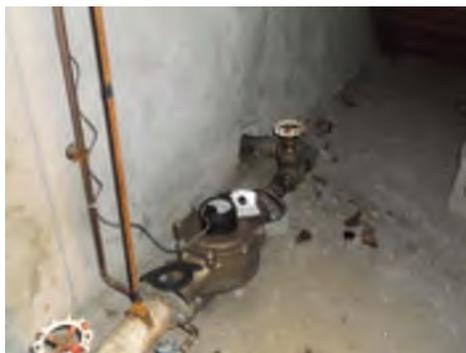
1. Domestic cold water enters the facility at the west wall of the building in a closet under the stairway at the lower level. The water entrance size is 2" and currently does not have backflow prevention, only an inline water meter. Piping is copper with vintage pipe insulation.

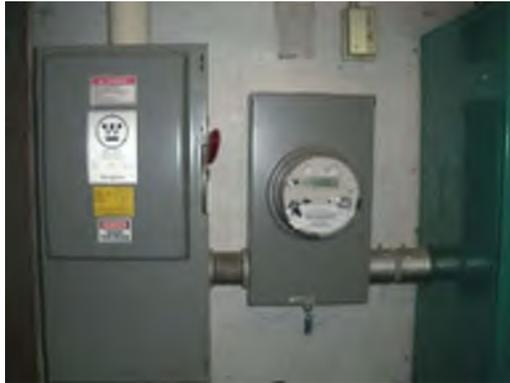
200 Amp Disconnect and Meter

The building is powered by a 200amp 120/208volt three-phase 4-wire underground service that originates at a 25-kVA utility-owned pole mounted transformer. This feed enters the custodial Workshop located in Room 006 and is connected to a 200 amp disconnect which then runs through a meter to an Onan ATS and ultimately feeds a 200 amp panel named Panel 0001. Panel 0001 is a 54-circuit panel. The panel directory installed in this panel is a directory for another panel located elsewhere in the building and is incorrect. AEI believes that a 70 amp circuit breaker in this panel feeds the 1st Floor Subpanel located outside of the Holding Area (Room120). These two panels' combined circuit capability is 96 circuits. However, Panel 0001 appears to have no spare circuiting available. The 1st Floor Subpanel does have a few spare circuit breaker spaces, but little to no available power capacity given the system's ampacity.

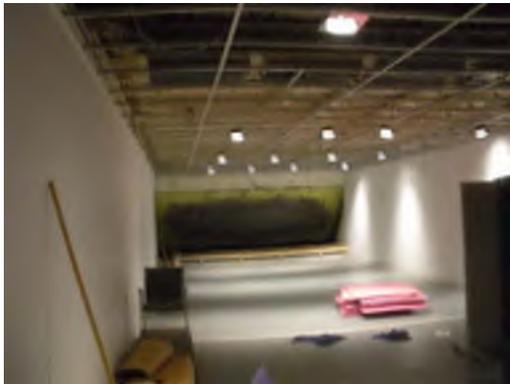
Firing Range Lighting

today the recessed lighting located in the firing range is in poor condition, non-energy-efficient, and the lighting control itself, while functional, is not listed or approved as required current NEC standards.

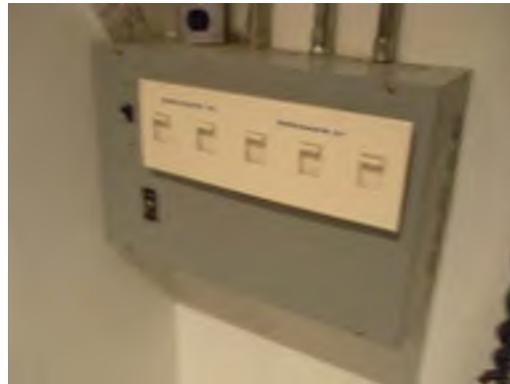
Firing Range Lighting Control – Non- UL Listed Assembly

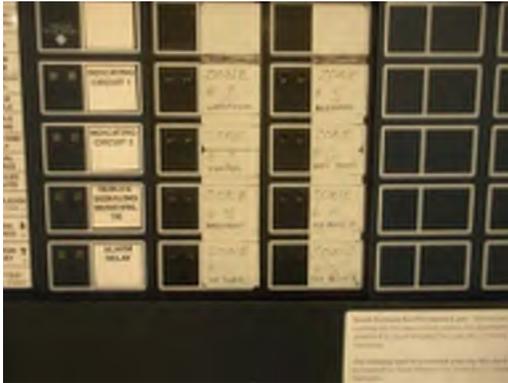
Type Written Labels Preferred

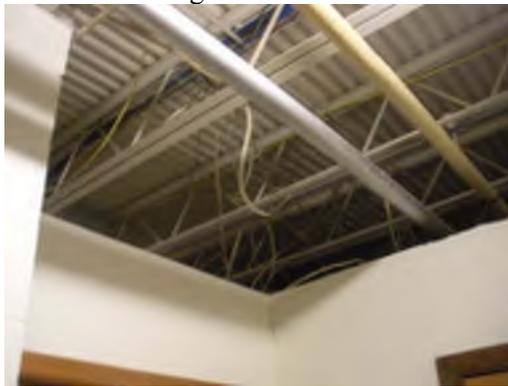
Poor Romex Installation (TYP)

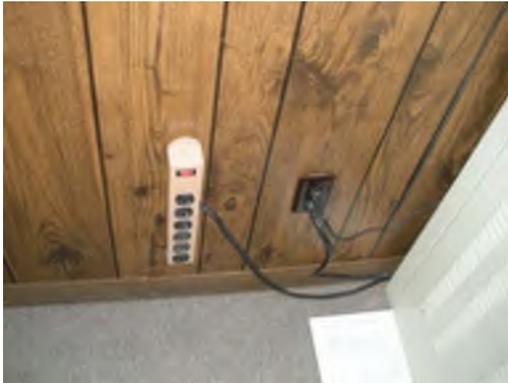
Extensive Use of Extension Cords and Power Strips (TYP)

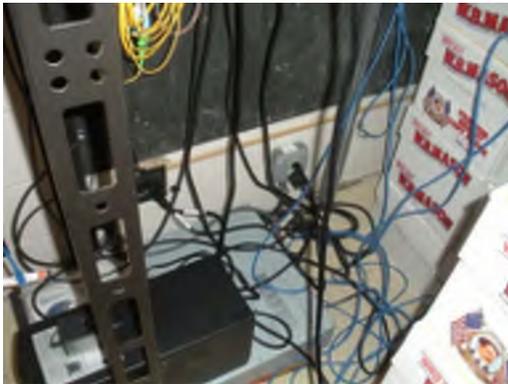
Poor Cable Management

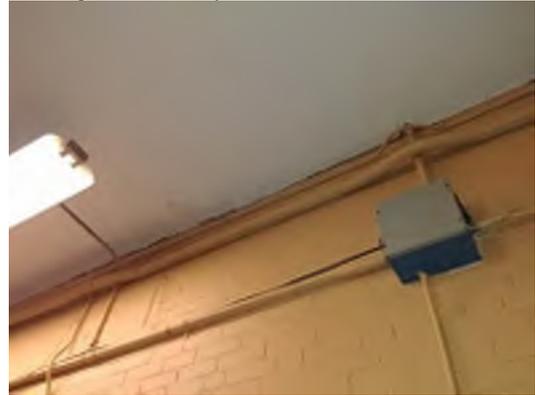
Peeling Paint in Bays

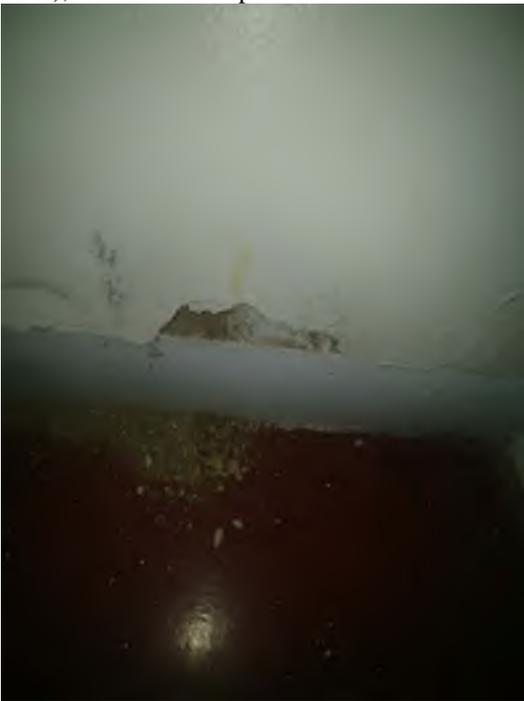
Close-up image of previous photo

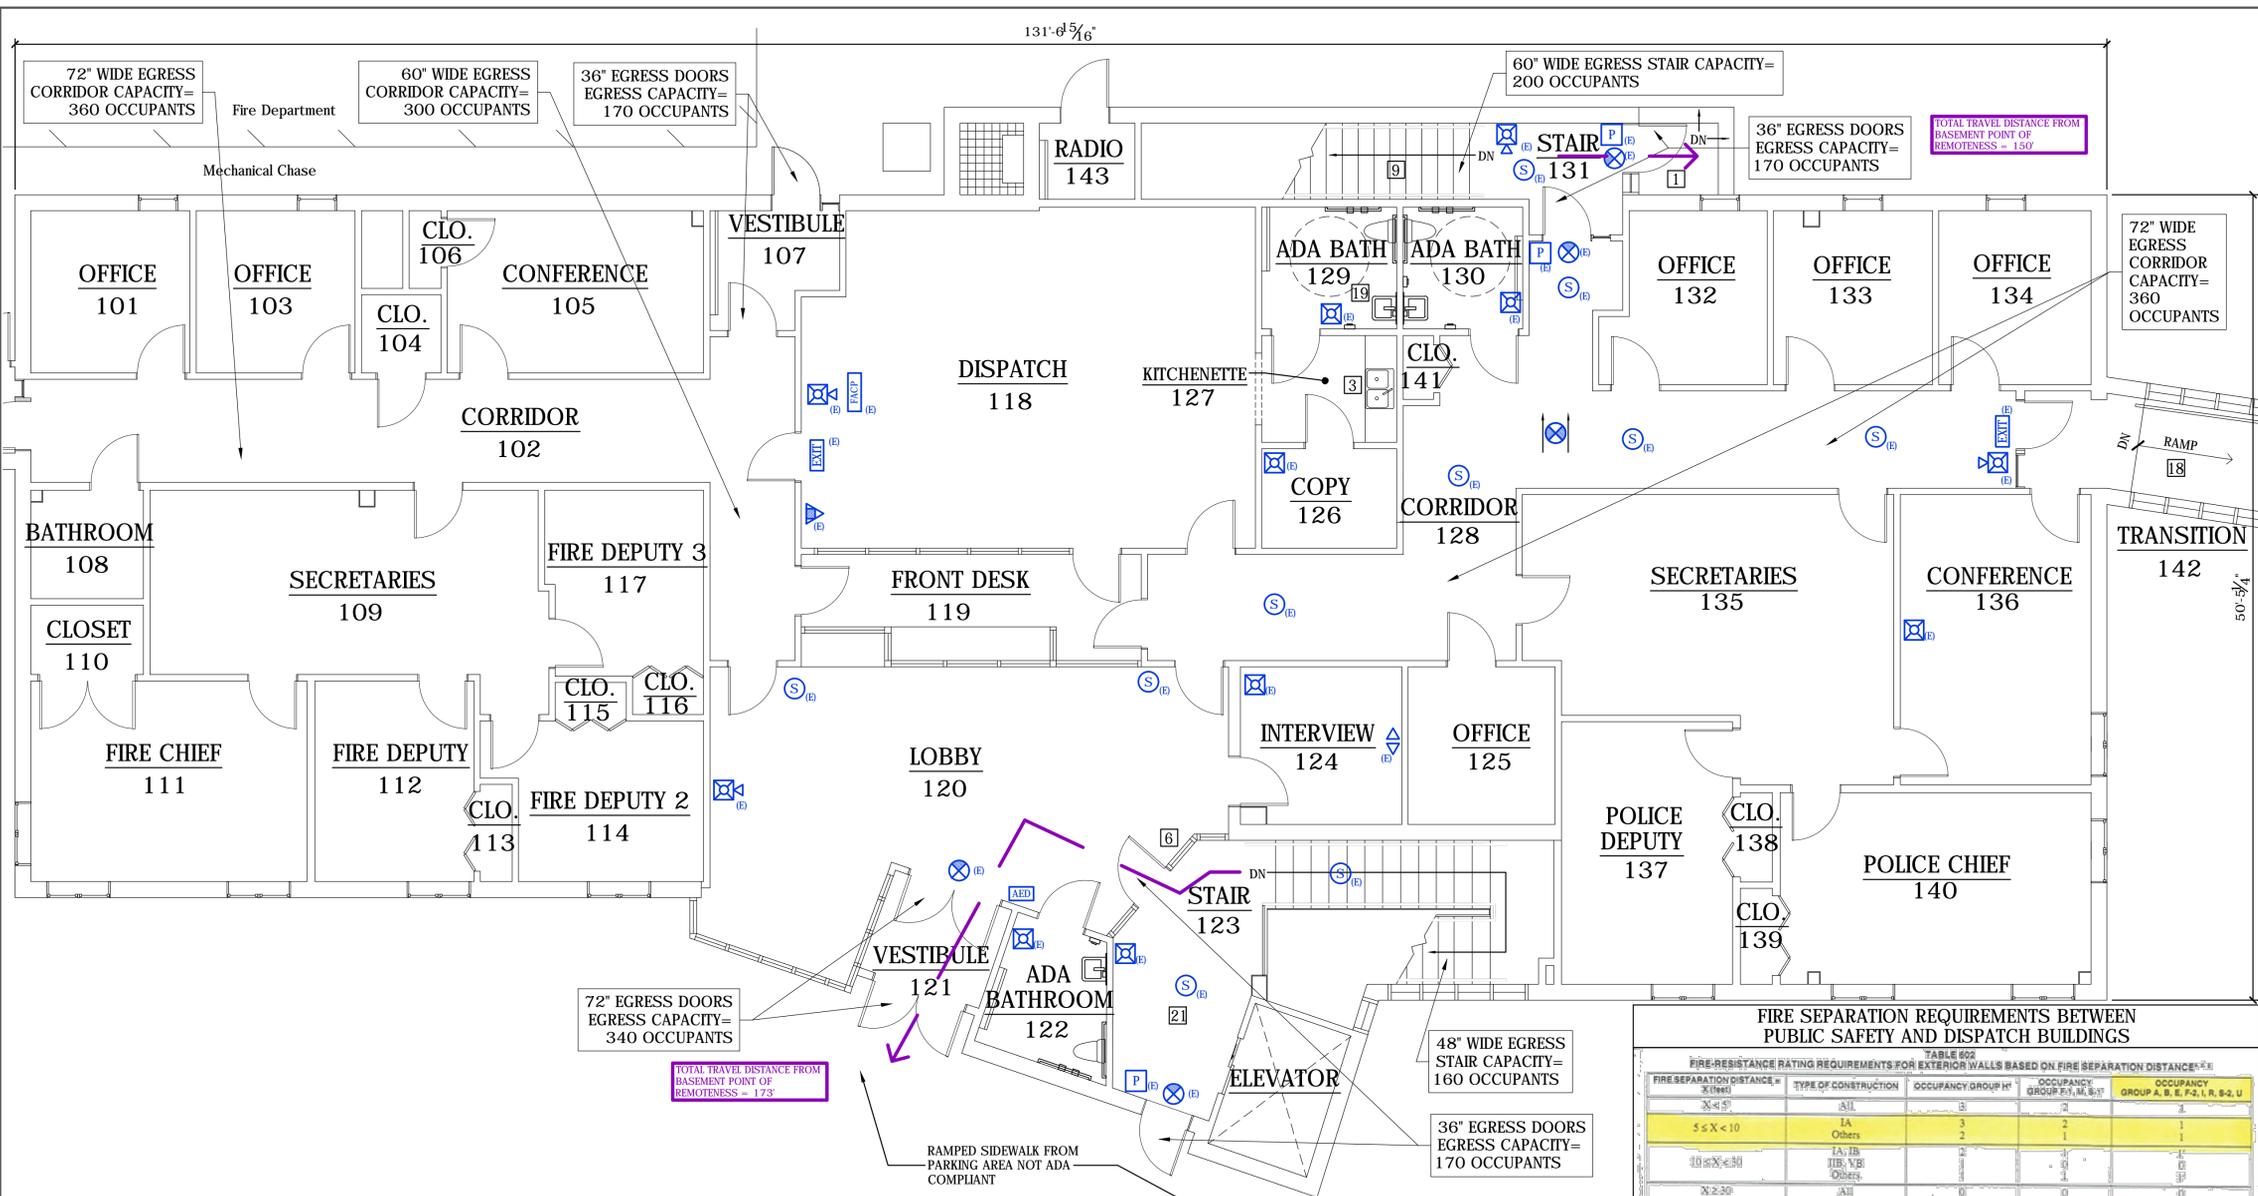
DISPATCH BUILDING LEVEL 1 CODE COMPLIANCE PLAN
 SCALE: 3/16" = 1'-0" 6,670 SF

BUILDING KEYED NOTES LEGEND	
1 REQUIRED EXIT DOES NOT COMPLY WITH ADA (NEEDS RAMP +/- 13'-0").	14 STAIR RISER / TREAD DO NOT COMPLY.*
2 TOILET ROOM DOES NOT COMPLY WITH ADA (DIMENSIONAL CRITERIA).	15 FIRE RATED DOOR DOES NOT HAVE POSITIVE LATCHING HARDWARE.
3 SINK DOES NOT COMPLY WITH ADA (NOT WHEELCHAIR ACCESSIBLE).	16 SHOWER NOT ADA COMPLIANT.
4 DOOR DOES NOT COMPLY WITH ADA (NOT WHEELCHAIR ACCESSIBLE).	17 RAMP DOES NOT HAVE ADA HANDRAIL BOTH SIDES.
5 DOOR HARDWARE NOT ADA COMPLIANT (KNOB).	18 NO SPRINKLER IN ROOM.
6 DOOR ASSEMBLY NOT 1 HR FIRE RATED AT EGRESS CORRIDOR (NON-SPRINKLED).	19 TOILET ACCESSORY HEIGHT DOES NOT COMPLY W/ ADA.
7 DOOR DOES NOT HAVE ADA WHEELCHAIR MINIMUM CLEARANCE APPROACH @ HARDWARE.	20 RANGE DOES NOT HAVE NFPA EXHAUST HOOD.
8 STAIR RAILING DOES NOT HAVE CODE COMPLIANT EXTENSIONS.*	21 ELEVATOR LOBBY NOT SEPARATED FROM EGRESS STAIR FIRE RATED ENCLOSURE.
9 STAIR RAILING HEIGHT / OPENINGS DO NOT COMPLY.*	22 MAXIMUM ALLOWED EGRESS TRAVEL DISTANCE DOES NOT COMPLY WITH IBC / NFPA 101

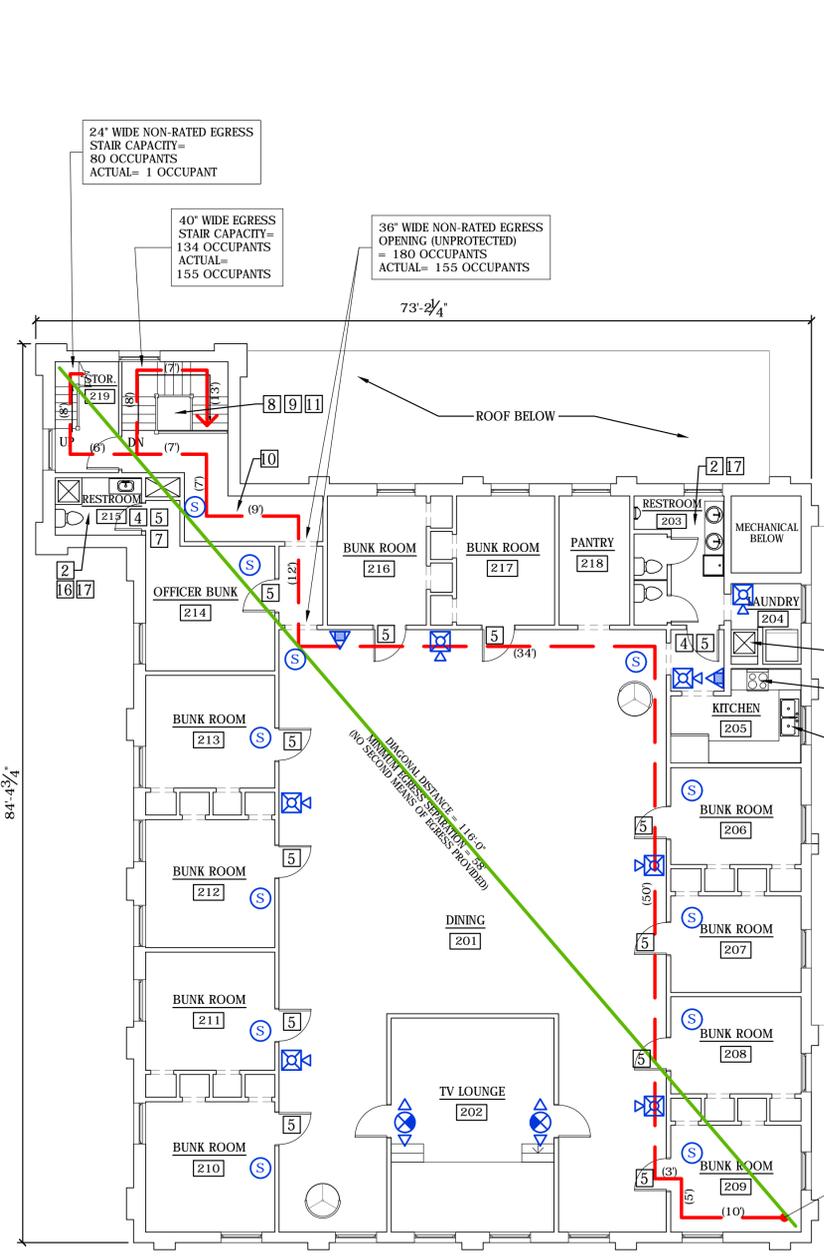
CENTRAL FIRE STATION SECOND FLOOR PLAN
SCALE: 1/8" = 1'-0"

- MAJORITY OF DOORS DO NOT HAVE ADA COMPLIANT HARDWARE (LEVERS).
- TOILET ROOMS ARE NON-COMPLIANT.
- KITCHEN SINK IS NON-COMPLIANT.
- EXITS ARE NON-COMPLIANT.
- STAIRS ARE NON-COMPLIANT.
- NO ACCESS TO SECOND FLOOR.

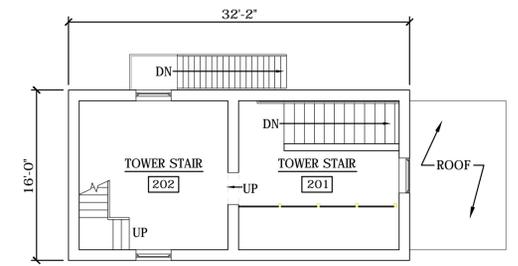
FIRE TRAINING TOWER LEVEL 1 PLAN
 SCALE: 1/8" = 1'-0"

BUILDING KEYED NOTES LEGEND			
1	REQUIRED EXIT DOES NOT COMPLY WITH ADA.	16	SHOWER NOT ADA COMPLIANT.
2	TOILET ROOM DOES NOT COMPLY WITH ADA (DIMENSIONAL CRITERIA).	17	TOILET ACCESSORY HEIGHT DOES NOT COMPLY w/ ADA.
3	SINK DOES NOT COMPLY WITH ADA (NOT WHEELCHAIR ACCESSIBLE).	18	RANGE DOES NOT HAVE NFPA EXHAUST HOOD.
4	DOOR DOES NOT COMPLY WITH ADA (NOT WHEELCHAIR ACCESSIBLE).	19	MAXIMUM ALLOWED EGRESS TRAVEL DISTANCE DOES NOT COMPLY WITH IBC / NFPA 101
5	DOOR HARDWARE NOT ADA COMPLIANT (KNOB).	20	STAIR WIDTH NOT CODE COMPLIANT.
6	DOOR ASSEMBLY NOT 1 HR FIRE RATED AT EGRESS CORRIDOR (NON-SPRINKLED).	21	STAIR DOES NOT HAVE GUARDRAIL / HANDRAIL.
7	DOOR DOES NOT HAVE ADA WHEELCHAIR MINIMUM CLEARANCE APPROACH @ HARDWARE.	22	VEHICLE MAINTENANCE BAYS & STORAGE BAYS DO NOT COMPLY WITH IBC/NFPA FOR FIRE PROTECTION (ALARMS / EXIT LIGHT / EMERGENCY LIGHTING).
8	STAIR RAILING DOES NOT HAVE CODE COMPLIANT EXTENSIONS.*		(* PER 2015 IBC / NFPA 101)
