Memorandum

Subject: Broadway at South Kelsey St. and Broadway at Hill St. Safety Study

The following memo details our evaluation of the intersections of Broadway at Hill Street and Hoyt Street and Broadway at South Kelsey Street in South Portland. It is our understanding that a number of residents of the area have expressed concerns relating to pedestrian and vehicular safety at these intersections. The following sections detail the existing conditions based on traffic volumes collected at the intersections, an overview of the three year crash history, and a summary of various traffic calming and pedestrian safety improvements for your consideration.

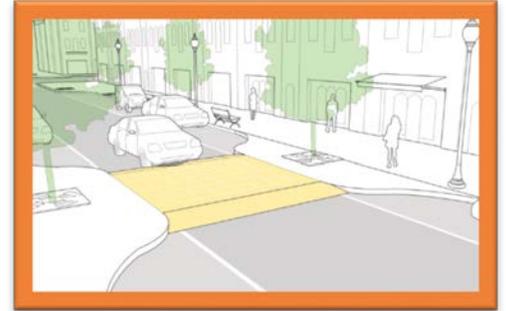
Speed tables reduce speeds by forcing traffic to significantly slow their speed in order to safely navigate the speed table. In general speed tables are found on low volume residential roads or within school campuses or parking lots to manage speeds. The Maine Department of Transportation has Guidelines for the use of traffic calming devices. In summary, the guidelines for minor arterials states that the prime function of the arterial is to provide mobility for transportation system users and that traffic calming on minor arterials should not be considered unless it can be shown that the 85th percentile speed is greater than 10 miles per hour over the posted and that other remediation hasn't shown improvement in speed compliance. In our opinion, speed tables should not be installed at this locations because of the congestion related crash history in this segment of Broadway and the high importance of mobility.
